General Information

Make	Toyota	Model	Vios
YOM	2025	Odo Meter Reading	15,288
Registration No.	DBP9517	Chassis No.	PA1B18F30R4265940
CC	1.3	Transmission	CVT
Fuel Type	Gas	Type of Body	Sedan
Colour	Blue

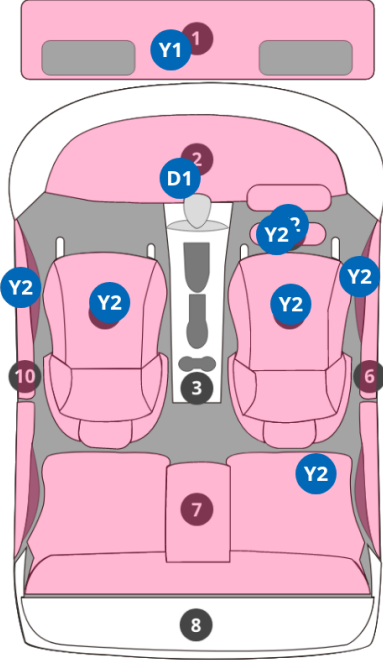
Interior Evaluation : B	Exterior Evaluation : D

<p>a : Cut, Fray d : Loose, Deformed k : Animal Hair s : Smell t : Cigarette Burns x : Defective y : Stain</p>

<p>A : Scratch AU : Scratch & Dent B : Modified C : Corrosion G : Stone chip P : Faded S : Rust SC : Rust & Corrosion U : Dent X : Defective Y : Crack, Gap</p>
Remarks (L) Front Seat - Grime - Small / (R) Front Seat - Grime - Small / Dashboard - Worked - Minimal / (R) Front Floor Mat - Grime - Small / (L) Front Floor Mat - Grime - Small / (L) Front Trim - Grime - Small / (R) Front Trim - Grime - Small / Rear Seat - Grime - Small / Ceiling - Grime - Minimal	Remarks (L) Front Door, Molding - Scratch & Dent - Small / (L) Rear Door, Molding - Scratch & Dent - Small / (L) Rear Fender, Molding - Scratch & Dent - Small / Rear Bumper, Lamps, Panels - Scratch - Medium / Trunk Hood, Rear Gate - Scratch & Dent - Small / (R) Rear Fender, Molding - Scratch & Dent - Small / (R) Rear Door, Molding - Scratch & Dent - Small / (R) Step, In-panel, Side Spoiler - Scratch & Dent - Small / (R) Front Door, Molding - Scratch - Medium / Roof - Scratch & Dent - Small / Bonnet, Headlight - Scratch - Small / Front Bumper, Grille, Lamps - Scratch & Dent - Small / (L) Front Fender, Molding - Scratch & Dent - Small / (R) Front Fender, Molding - Scratch & Dent - Small / (L) Step, In-panel, Side Spoiler - Scratch & Dent - Small

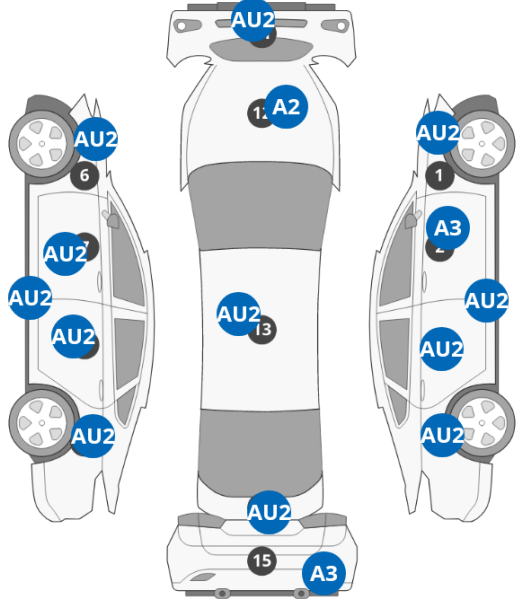
Inspector Notes
with LTO plate, with manual & warranty booklet, with spare tire, with inc tools & jack, with reverse camera, no spare key, scratches on taillight.
