General Information

Make	Toyota	Model	Vios
YOM	2025	Odo Meter Reading	16,392
Registration No.	DBR9552	Chassis No.	PA1B18F3XR4280350
CC	1.3	Transmission	CVT
Fuel Type	Gas	Type of Body	Sedan
Colour	Blue

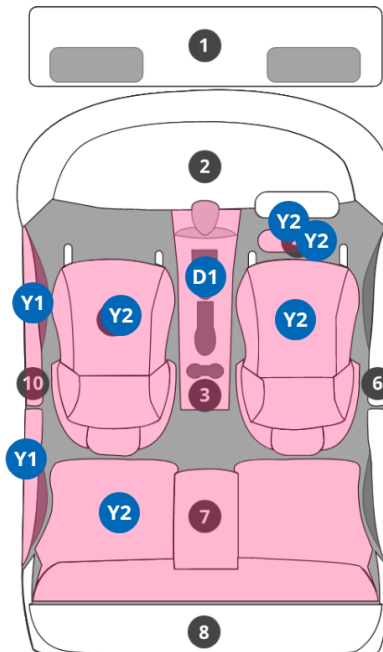
Interior Evaluation : B	Exterior Evaluation : E

<p>a : Cut, Fray d : Loose, Deformed k : Animal Hair s : Smell t : Cigarette Burns x : Defective y : Stain</p>

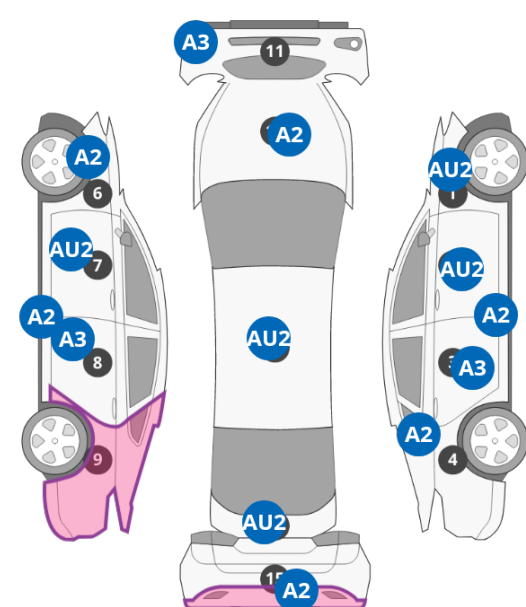
<p>A : Scratch AU : Scratch & Dent B : Modified C : Corrosion G : Stone chip P : Faded S : Rust SC : Rust & Corrosion U : Dent X : Defective Y : Crack, Gap</p>
<p>Remarks (L) Front Seat - Grime - Small / (R) Front Seat - Grime - Small / (R) Front Floor Mat - Grime - Small / (L) Front Floor Mat - Grime - Small / Rear Seat - Grime - Small / Console, Switches, Vents - Worked - Minimal / (L) Front Trim - Grime - Minimal / (L) Rear Trim - Grime - Minimal</p>	<p>Remarks (L) Rear Fender - Repair Traces - Yes / (L) Rear Fender, Molding - Repair mark - Yes / Rear Bumper, Lamps, Panels - Repair mark - Yes / (L) Rear Door, Molding - Scratch - Medium / (L) Front Door, Molding - Scratch & Dent - Small / (L) Step, In-panel, Side Spoiler - Scratch - Small / Roof - Scratch & Dent - Small / (L) Front Fender, Molding - Scratch - Small / Front Bumper, Grille, Lamps - Scratch - Medium / Bonnet, Headlight - Scratch - Small / (R) Front Fender, Molding - Scratch & Dent - Small / (R) Front Door, Molding - Scratch & Dent - Small / (R) Step, In-panel, Side Spoiler - Scratch - Small / (R) Rear Door, Molding - Scratch - Medium / (R) Rear Fender, Molding - Scratch - Small / Trunk Hood, Rear Gate - Scratch & Dent - Small / Rear Bumper, Lamps, Panels - Scratch - Small</p>
