## General Information

Make	Toyota	Model	Vios
YOM	2024	Odo Meter Reading	17,343
Registration No.	EAJ4761	Chassis No.	PA1B18F39R4259604
CC	1.3	Transmission	CVT
Fuel Type	Gas	Type of Body	Sedan
Colour	Silver

## Body / Panel Condition

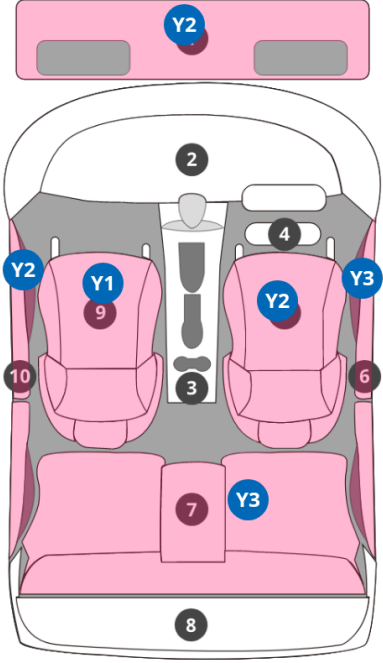
<b>Interior Evaluation :</b> <span style="float: right;"><b>B</b></span>	<b>Exterior Evaluation :</b> <span style="float: right;"><b>B</b></span>

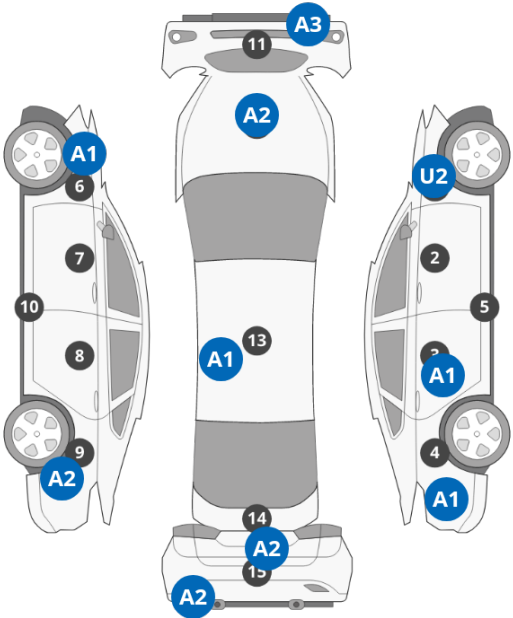
<p><b>A</b> : Scratch <b>AU</b> : Scratch &amp; Dent <b>B</b> : Modified <b>C</b> : Corrosion <b>G</b> : Stone chip <b>P</b> : Faded <b>S</b> : Rust <b>SC</b> : Rust &amp; Corrosion <b>U</b> : Dent <b>X</b> : Defective <b>Y</b> : Crack, Gap</p>
<p><b>Remarks</b> (R) Front Seat - Grime - Small / (R) Front Trim - Grime - Medium / Rear Seat - Grime - Medium / (L) Front Trim - Grime - Small / (L) Front Seat - Grime - Minimal / Ceiling - Grime - Small</p>	<p><b>Remarks</b> Trunk Hood, Rear Gate - Scratch - Small / Front Bumper, Grille, Lamps - Scratch - Medium / Bonnet, Headlight - Scratch - Small / (L) Front Fender, Molding - Scratch - Minimal / Roof - Scratch - Minimal / (R) Rear Fender, Molding - Scratch - Minimal / (R) Rear Door, Molding - Scratch - Minimal / (R) Front Fender, Molding - Dent - Small / Rear Bumper, Lamps, Panels - Scratch - Small / (L) Rear Fender, Molding - Scratch - Small</p>
