## General Information

<b>Make</b>	Toyota	<b>Model</b>	Vios
<b>YOM</b>	2023	<b>Odo Meter Reading</b>	89,133
<b>Registration No.</b>	NHJ1214	<b>Chassis No.</b>	PA1B18F34P4215135
<b>CC</b>	1.3	<b>Transmission</b>	CVT
<b>Fuel Type</b>	Gas	<b>Type of Body</b>	Sedan
<b>Colour</b>	Green

## Body / Panel Condition

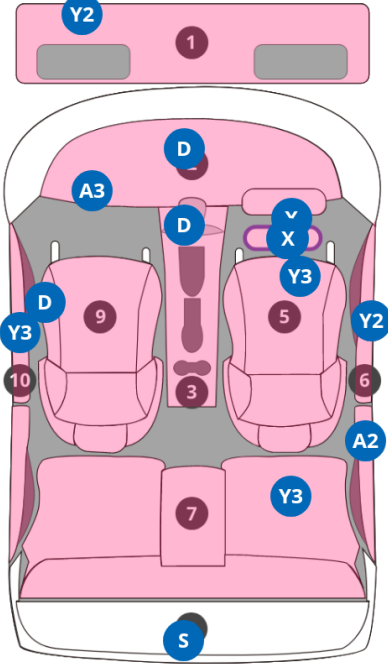
<b>Interior Evaluation :</b> <span style="float: right; color: red; font-weight: bold;">C</span>	<b>Exterior Evaluation :</b> <span style="float: right; color: red; font-weight: bold;">E</span>

<p><b>a :</b> Cut, Fray <b>d :</b> Loose, Deformed <b>k :</b> Animal Hair <b>s :</b> Smell <b>t :</b> Cigarette Burns <b>x :</b> Defective <b>y :</b> Stain</p>

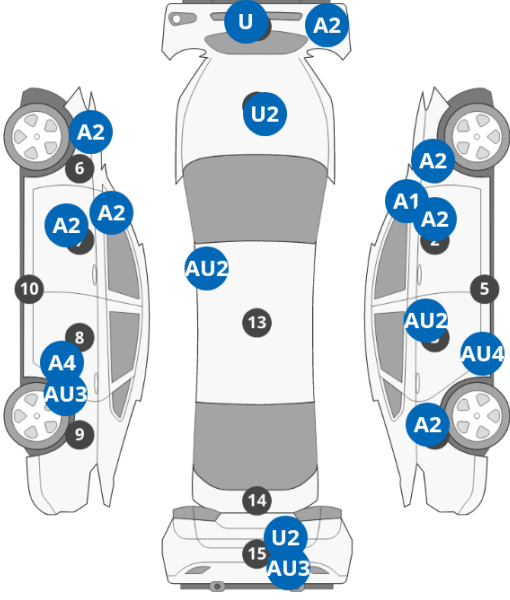
<p><b>A :</b> Scratch <b>AU :</b> Scratch &amp; Dent <b>B :</b> Modified <b>C :</b> Corrosion <b>G :</b> Stone chip <b>P :</b> Faded <b>S :</b> Rust <b>SC :</b> Rust &amp; Corrosion <b>U :</b> Dent <b>X :</b> Defective <b>Y :</b> Crack, Gap</p>
<p><b>Remarks</b> Overall Interior - Smell - Yes / Mat Other - Missing - Yes / (R) Front Floor Mat - Missing - Yes / (L) Front Floor Mat - Missing - Yes / (L) Front Seat - Worn - Yes / (R) Front Seat - Grime - Medium / Rear Seat - Grime - Medium / Dashboard - Traces of Adhesive Tape - Yes / Ceiling - Grime - Small / (R) Rear Trim - Cut, Crack - Small / (R) Front Trim - Grime - Small / (L) Front Trim - Grime - Medium / Overall Interior - Worn as per age - Yes / Steering Wheel - Worn, Peel, Crack - Medium / Console, Switches, Vents - Traces of Adhesive Tape - Yes</p>	<p><b>Remarks</b> (R) Front Fender, Molding - Scratch - Small / (R) Mirror - Scratch - Minimal / (R) Step, In-panel, Side Spoiler - Scratch &amp; Dent - Large / (R) Front Door, Molding - Scratch - Small / (R) Rear Fender, Molding - Scratch - Small / Rear Bumper, Lamps, Panels - Scratch &amp; Dent - Medium / Trunk Hood, Rear Gate - Dent - Small / (L) Rear Fender, Molding - Scratch &amp; Dent - Medium / (L) Rear Door, Molding - Scratch - Large / (L) Front Door, Molding - Scratch - Small / (L) Mirror - Scratch - Small / (L) Front Fender, Molding - Scratch - Small / Member (Bolted) - Dent - Yes / Front Bumper, Grille, Lamps - Scratch - Small / Bonnet, Headlight - Dent - Small / Roof - Scratch &amp; Dent - Small / (R) Rear Door, Molding - Scratch &amp; Dent - Small</p>

<p><b>Inspector Notes</b></p>
<p>no warranty booklet, jack and tools, with spare tire, with LTO plate, scratches on tail light, possible flooding, park and plate light issue</p>
