General Information

Make	Toyota	Model	Vios
YOM	2025	Odo Meter Reading	18,923
Registration No.	NHU5739	Chassis No.	PA1B18F30R4272211
CC	1.3	Transmission	CVT
Fuel Type	Gas	Type of Body	Sedan
Colour	Red

Body / Panel Condition

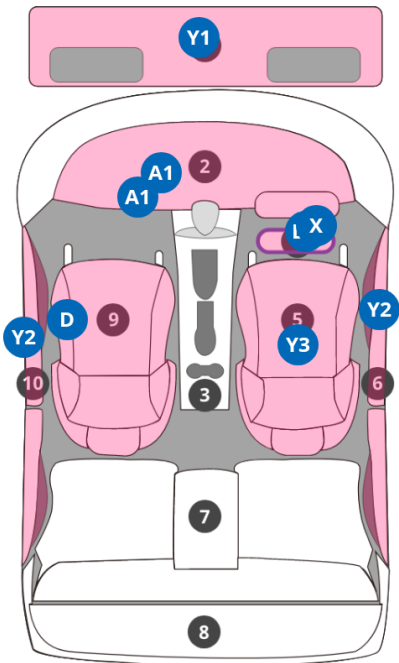
Interior Evaluation : B	Exterior Evaluation : D

<p>a : Cut, Fray d : Loose, Deformed k : Animal Hair s : Smell t : Cigarette Burns x : Defective y : Stain</p>

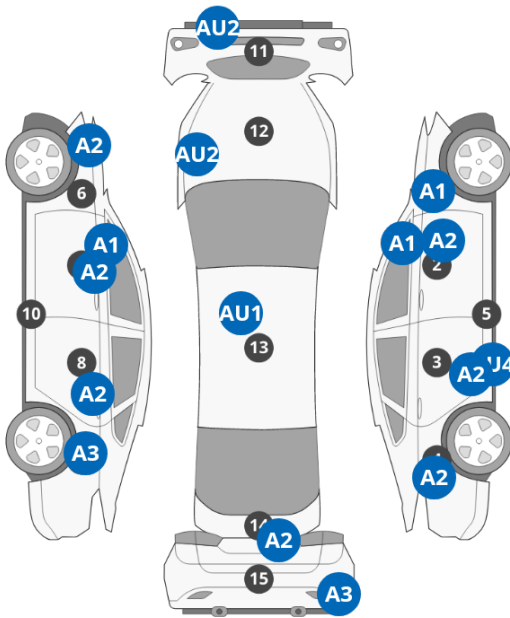
<p>A : Scratch AU : Scratch & Dent B : Modified C : Corrosion G : Stone chip P : Faded S : Rust SC : Rust & Corrosion U : Dent X : Defective Y : Crack, Gap</p>
<p>Remarks (L) Front Seat - Worn - Yes / (R) Front Seat - Grime - Medium / (L) Front Floor Mat - Worked - Small / Mat Other - Missing - Yes / (L) Front Trim - Grime - Small / (R) Front Trim - Grime - Small / Instrument Panel - Worn, Scratch, Cut, Crack - Minimal / Dashboard - Worn, Scratch, Cut, Crack - Minimal / Ceiling - Grime - Minimal</p>	<p>Remarks (R) Front Fender, Molding - Scratch - Minimal / (R) Mirror - Scratch - Minimal / (R) Step, In-panel, Side Spoiler - Scratch & Dent - Large / (R) Front Door, Molding - Scratch - Small / (R) Rear Door, Molding - Scratch - Small / (R) Rear Fender, Molding - Scratch - Small / Rear Bumper, Lamps, Panels - Scratch - Medium / Trunk Hood, Rear Gate - Scratch - Small / (L) Rear Fender, Molding - Scratch - Medium / (L) Rear Door, Molding - Scratch - Small / (L) Mirror - Scratch - Minimal / (L) Front Door, Molding - Scratch - Small / Bonnet, Headlight - Scratch & Dent - Small / (L) Front Fender, Molding - Scratch - Small / Front Bumper, Grille, Lamps - Scratch & Dent - Small / Roof - Scratch & Dent - Minimal</p>
