General Information

Make	Toyota	Model	Vios
YOM	2023	Odo Meter Reading	80,086
Registration No.	NIG9198	Chassis No.	PA1B18F36N4200021
CC	1.3	Transmission	CVT
Fuel Type	Gas	Type of Body	Sedan
Colour	Silver

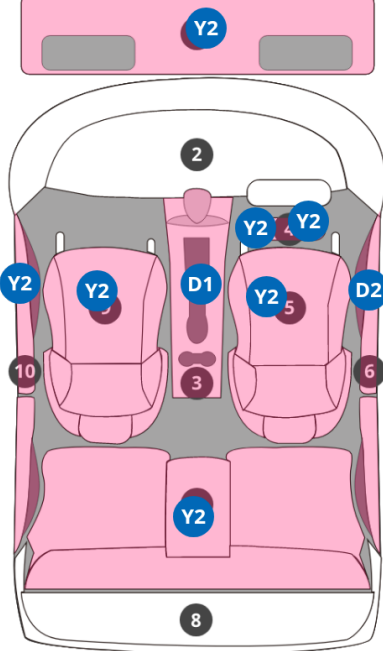
Interior Evaluation : B	Exterior Evaluation : E

<p>a : Cut, Fray d : Loose, Deformed k : Animal Hair s : Smell t : Cigarette Burns x : Defective y : Stain</p>

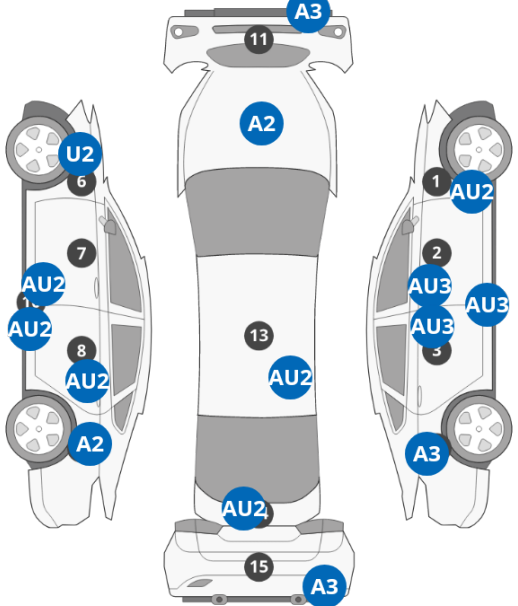
<p>A : Scratch AU : Scratch & Dent B : Modified C : Corrosion G : Stone chip P : Faded S : Rust SC : Rust & Corrosion U : Dent X : Defective Y : Crack, Gap</p>
<p>Remarks (R) Front Trim - Worked - Small / (L) Front Trim - Grime - Small / (L) Front Seat - Grime - Small / (R) Front Seat - Grime - Small / Rear Seat - Grime - Small / (L) Front Floor Mat - Grime - Small / (R) Front Floor Mat - Grime - Small / Ceiling - Grime - Small</p>	<p>Remarks Roof - Repair Traces - Yes / (R) Front Door, Molding - Scratch & Dent - Medium / (R) Step, In-panel, Side Spoiler - Scratch & Dent - Medium / (R) Rear Door, Molding - Scratch & Dent - Medium / (R) Rear Fender, Molding - Scratch - Medium / Rear Bumper, Lamps, Panels - Scratch - Medium / Trunk Hood, Rear Gate - Scratch & Dent - Small / (L) Rear Fender, Molding - Scratch - Small / Roof - Scratch & Dent - Small / (L) Rear Door, Molding - Scratch & Dent - Small / (L) Front Door, Molding - Scratch & Dent - Small / (L) Front Fender, Molding - Scratch & Dent - Small / Front Bumper, Grille, Lamps - Scratch - Medium / (R) Front Fender, Molding - Scratch & Dent - Small / (L) Step, In-panel, Side Spoiler - Scratch & Dent - Small / Bonnet, Headlight - Scratch - Small</p>
