General Information

Make	Toyota	Model	Vios
YOM	2025	Odo Meter Reading	30,252
Registration No.	NKE8266	Chassis No.	PA1B18F37R4265370
CC	1.3	Transmission	CVT
Fuel Type	Gas	Type of Body	Sedan
Colour	Blue

Body / Panel Condition

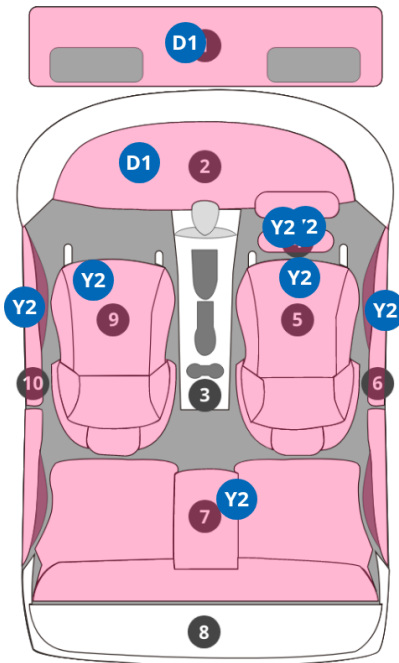
Interior Evaluation : B	Exterior Evaluation : D

<p>a : Cut, Fray d : Loose, Deformed k : Animal Hair s : Smell t : Cigarette Burns x : Defective y : Stain</p>

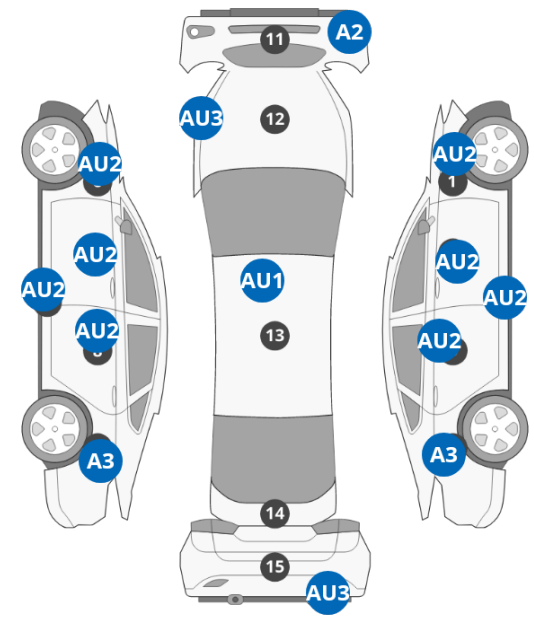
<p>A : Scratch AU : Scratch & Dent B : Modified C : Corrosion G : Stone chip P : Faded S : Rust SC : Rust & Corrosion U : Dent X : Defective Y : Crack, Gap</p>
<p>Remarks (L) Front Seat - Grime - Small / (R) Front Seat - Grime - Small / (R) Front Floor Mat - Grime - Small / (L) Front Floor Mat - Grime - Small / Dashboard - Loose, Deformed - Minimal / Ceiling - Crinkle - Minimal / Rear Seat - Grime - Small / (R) Front Trim - Grime - Small / (L) Front Trim - Grime - Small</p>	<p>Remarks (R) Front Door - Repair Traces - Yes / Roof - Repair Traces - Yes / Roof - Scratch & Dent - Minimal / (L) Front Fender, Molding - Scratch & Dent - Small / Bonnet, Headlight - Scratch & Dent - Medium / Front Bumper, Grille, Lamps - Scratch - Small / (R) Front Fender, Molding - Scratch & Dent - Small / (R) Front Door, Molding - Scratch & Dent - Small / (R) Step, In-panel, Side Spoiler - Scratch & Dent - Small / (R) Rear Door, Molding - Scratch & Dent - Small / (R) Rear Fender, Molding - Scratch - Medium / Rear Bumper, Lamps, Panels - Scratch & Dent - Medium / Trunk Hood, Rear Gate - Scratch & Dent - Small / (L) Rear Fender, Molding - Scratch - Medium / (L) Rear Door, Molding - Scratch & Dent - Small / (L) Front Door, Molding - Scratch & Dent - Small / (L) Step, In-panel, Side Spoiler - Scratch & Dent - Small</p>
