General Information

Make	Toyota	Model	Vios
YOM	2025	Odo Meter Reading	5,818
Registration No.	NKH2695	Chassis No.	PA1B18F39R4275124
CC	1.3	Transmission	CVT
Fuel Type	Gas	Type of Body	Sedan
Colour	Silver

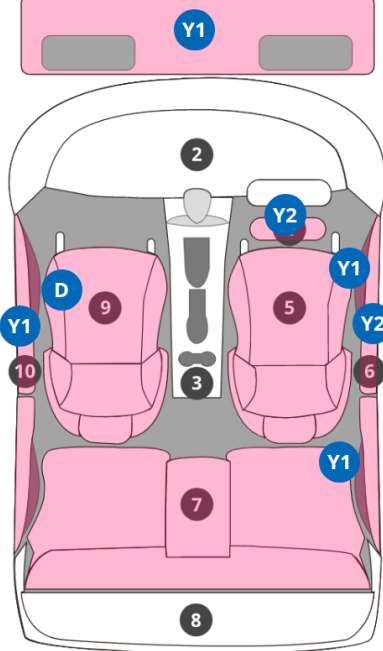
Interior Evaluation : B	Exterior Evaluation : C

<p>a : Cut, Fray d : Loose, Deformed k : Animal Hair s : Smell t : Cigarette Burns x : Defective y : Stain</p>

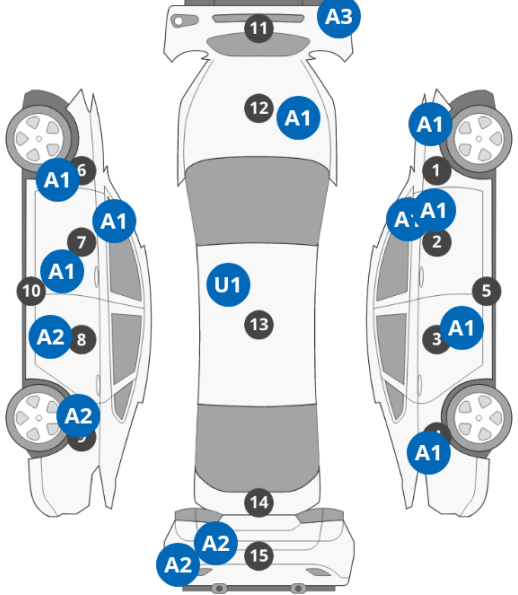
<p>A : Scratch AU : Scratch & Dent B : Modified C : Corrosion G : Stone chip P : Faded S : Rust SC : Rust & Corrosion U : Dent X : Defective Y : Crack, Gap</p>
<p>Remarks (L) Front Seat - Worn - Yes / (L) Front Floor Mat - Worked - Small / (R) Front Trim - Grime - Small / (L) Front Trim - Grime - Minimal / (R) Front Seat - Grime - Minimal / Ceiling - Grime - Minimal / Rear Seat - Grime - Minimal / (R) Front Floor Mat - Grime - Small</p>	<p>Remarks (R) Front Fender, Molding - Scratch - Minimal / (R) Mirror - Scratch - Minimal / (R) Front Door, Molding - Scratch - Minimal / (R) Rear Door, Molding - Scratch - Minimal / (R) Rear Fender, Molding - Scratch - Minimal / Rear Bumper, Lamps, Panels - Scratch - Small / Trunk Hood, Rear Gate - Scratch - Small / (L) Rear Fender, Molding - Scratch - Small / (L) Front Door, Molding - Scratch - Minimal / (L) Rear Door, Molding - Scratch - Small / (L) Mirror - Scratch - Minimal / (L) Front Fender, Molding - Scratch - Minimal / Front Bumper, Grille, Lamps - Scratch - Medium / Bonnet, Headlight - Scratch - Minimal / Roof - Dent - Minimal</p>

<p>Inspector Notes</p>
<p>with warranty booklet, jack and tools, with spare tire, with LTO plate, scratches on tail light</p>
