General Information

Make	Toyota	Model	Hilux
YOM	2025	Odo Meter Reading	8,153
Registration No.	NKO9944	Chassis No.	MR0JB8DD7S3236691
CC	2.4	Transmission	A/T
Fuel Type	Diesel	Type of Body	Pickup
Colour	Black

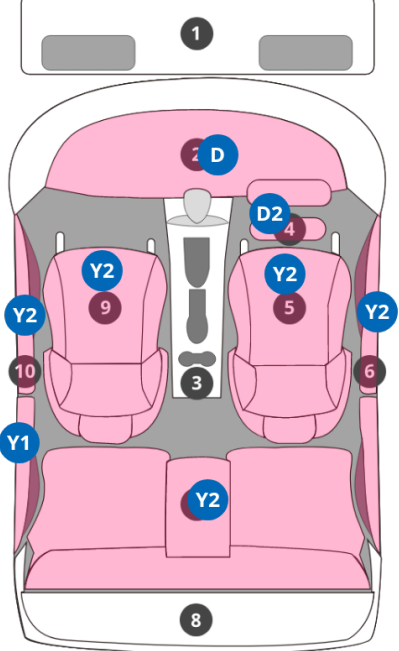
Interior Evaluation : B	Exterior Evaluation : C

<p>a : Cut, Fray d : Loose, Deformed k : Animal Hair s : Smell t : Cigarette Burns x : Defective y : Stain</p>

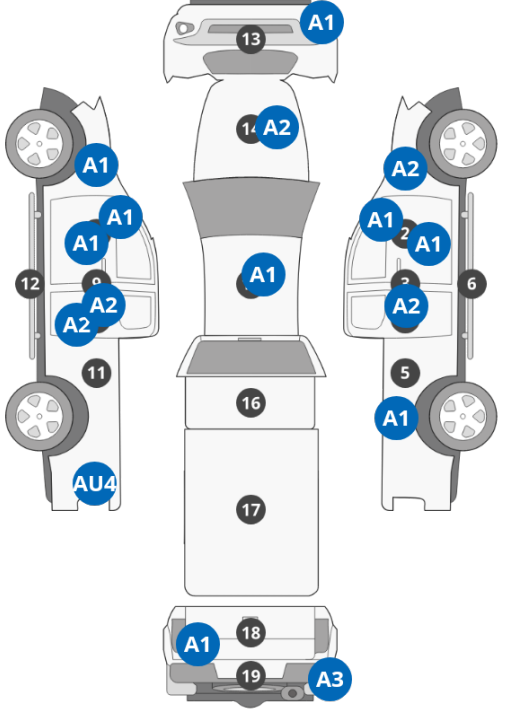
<p>A : Scratch AU : Scratch & Dent B : Modified C : Corrosion G : Stone chip P : Faded S : Rust SC : Rust & Corrosion U : Dent X : Defective Y : Crack, Gap</p>
<p>Remarks (R) Front Trim - Grime - Small / (L) Front Trim - Grime - Small / (L) Rear Trim - Grime - Minimal / Dashboard - Traces of Adhesive Tape - Yes / (L) Front Floor Mat - Worked - Small / (R) Front Seat - Grime - Small / (L) Front Seat - Grime - Small / Rear Seat - Grime - Small</p>	<p>Remarks (R) Front Fender, Molding - Scratch - Small / (R) Mirror - Scratch - Minimal / (R) Rear Door, Molding - Scratch - Small / (R) Front Door, Molding - Scratch - Minimal / (R) Side Gate - Scratch - Minimal / Rear Bumper, Lamps, Panels - Scratch - Medium / Rear Gate - Scratch - Minimal / (L) Side Gate - Scratch & Dent - Large / (L) Center Panel - Scratch - Small / (L) Rear Door, Molding - Scratch - Small / (L) Front Door, Molding - Scratch - Minimal / (L) Mirror - Scratch - Minimal / (L) Front Fender, Molding - Scratch - Minimal / Front Bumper, Grille, Lamps - Scratch - Minimal / Bonnet, Headlight - Scratch - Small / Roof - Scratch - Minimal</p>

<p>Inspector Notes</p>
<p>no warranty booklet, with jack and tools, with spare tire and LTO PLATE, scratched and cracked tail light</p>
