General Information

Make	Toyota	Model	Vios
YOM	2025	Odo Meter Reading	13,344
Registration No.	DBQ4453	Chassis No.	PA1B18F39R4269713
CC	1.3	Transmission	CVT
Fuel Type	Gas	Type of Body	Sedan
Colour	Blue

Body / Panel Condition

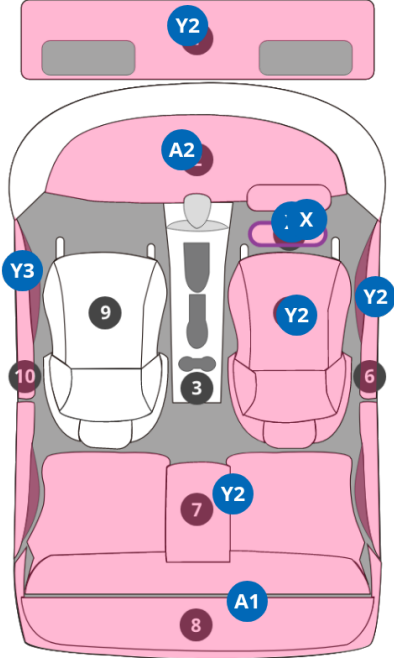
Interior Evaluation : B	Exterior Evaluation : E

<p>a : Cut, Fray d : Loose, Deformed k : Animal Hair s : Smell t : Cigarette Burns x : Defective y : Stain</p>

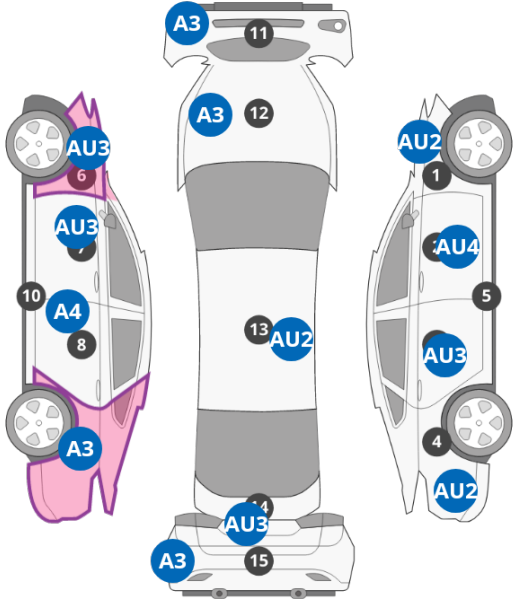
<p>A : Scratch AU : Scratch & Dent B : Modified C : Corrosion G : Stone chip P : Faded S : Rust SC : Rust & Corrosion U : Dent X : Defective Y : Crack, Gap</p>
<p>Remarks (R) Front Seat - Grime - Small / (R) Front Trim - Grime - Small / Rear Seat - Grime - Small / Trunk Room - Worn, Scratch, Cut, Crack - Minimal / (L) Front Trim - Grime - Medium / (R) Front Floor Mat - Missing - Yes / (L) Front Floor Mat - Missing - Yes / Ceiling - Grime - Small / Dashboard - Worn, Scratch, Cut, Crack - Small</p>	<p>Remarks (R) Front Door - Repair Traces - Yes / (R) Front Fender - Repair Traces - Yes / Bonnet - Repair Traces - Yes / (L) Front Fender - Repair Traces - Yes / (L) Rear Fender - Repair Traces - Yes / (R) Rear Fender - Repair Traces - Yes / (R) Rear Door - Repair Traces - Yes / Roof - Repair Traces - Yes / (L) Rear Fender, Molding - Repair mark - Yes / (L) Front Fender, Molding - Repair mark - Yes / (R) Rear Fender, Molding - Scratch & Dent - Small / (R) Rear Door, Molding - Scratch & Dent - Medium / (R) Front Door, Molding - Scratch & Dent - Large / (R) Front Fender, Molding - Scratch & Dent - Small / Roof - Scratch & Dent - Small / Bonnet, Headlight - Scratch - Medium / (L) Front Fender, Molding - Scratch & Dent - Medium / Front Bumper, Grille, Lamps - Scratch - Medium / (L) Front Door, Molding - Scratch & Dent - Medium / (L) Rear Door, Molding - Scratch - Large / (L) Rear Fender, Molding - Scratch - Medium / Trunk Hood, Rear Gate - Scratch & Dent - Medium / Rear Bumper, Lamps, Panels - Scratch - Medium</p>
