General Information

Make	Toyota	Model	Vios
YOM	2024	Odo Meter Reading	44,795
Registration No.	EAG6714	Chassis No.	PA1B18F38P4238448
CC	1.3	Transmission	CVT
Fuel Type	Gas	Type of Body	Sedan
Colour	Black

Body / Panel Condition

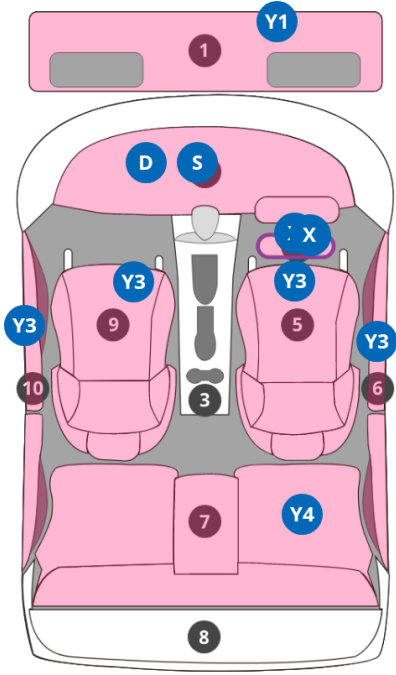
Interior Evaluation : C	Exterior Evaluation : C

<p>a : Cut, Fray d : Loose, Deformed k : Animal Hair s : Smell t : Cigarette Burns x : Defective y : Stain</p>

<p>A : Scratch AU : Scratch & Dent B : Modified C : Corrosion G : Stone chip P : Faded S : Rust SC : Rust & Corrosion U : Dent X : Defective Y : Crack, Gap</p>
<p>Remarks Overall Interior - Smell - Yes / (L) Front Floor Mat - Missing - Yes / (R) Front Floor Mat - Missing - Yes / Mat Other - Missing - Yes / (R) Front Seat - Grime - Medium / (L) Front Seat - Grime - Medium / Rear Seat - Grime - Large / (R) Front Trim - Grime - Medium / (L) Front Trim - Grime - Medium / Dashboard - Traces of Adhesive Tape - Yes / Ceiling - Grime - Minimal</p>	<p>Remarks (R) Front Fender, Molding - Scratch - Small / (R) Mirror - Scratch - Minimal / (R) Front Door, Molding - Scratch - Small / (R) Rear Door, Molding - Scratch - Small / (R) Rear Fender, Molding - Scratch & Dent - Small / Trunk Hood, Rear Gate - Scratch - Minimal / Rear Bumper, Lamps, Panels - Scratch - Small / (L) Rear Fender, Molding - Scratch - Small / (L) Front Door, Molding - Scratch - Medium / (L) Rear Door, Molding - Scratch - Small / (L) Mirror - Scratch - Minimal / (L) Front Fender, Molding - Scratch - Minimal / Front Bumper, Grille, Lamps - Scratch - Small / Bonnet, Headlight - Scratch - Minimal / Roof - Scratch - Small</p>

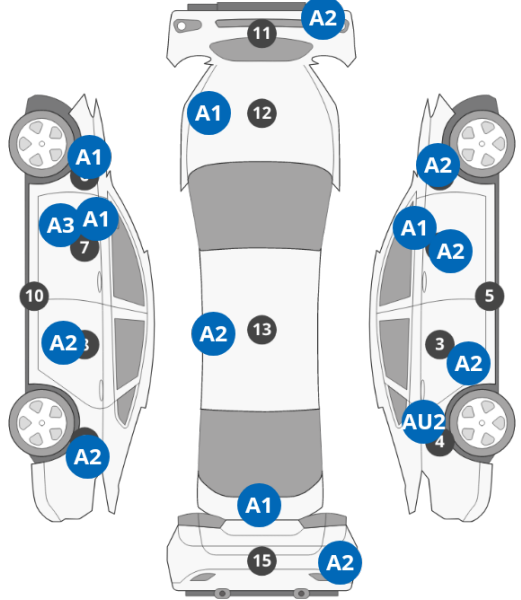
<p>Inspector Notes</p>
<p>no warranty booklet, with jack, incomplete tools, with spare tire, with LTO plate, scratches on tail light, possible flooding, plate light issue</p>
