General Information

Make	Toyota	Model	Vios
YOM	2025	Odo Meter Reading	21,648
Registration No.	DBR6009	Chassis No.	PA1B18F39R4278461
CC	1.3	Transmission	CVT
Fuel Type	Gas	Type of Body	Sedan
Colour	Black

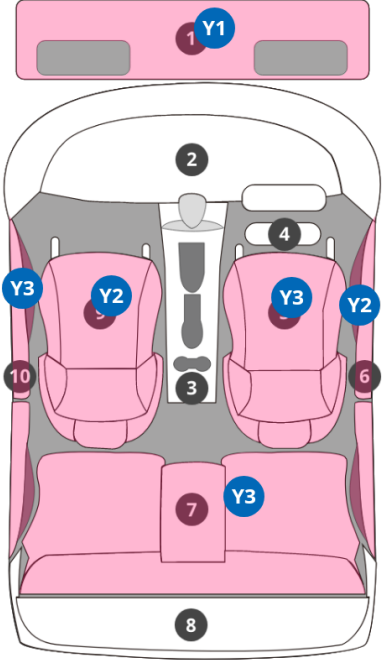
Interior Evaluation : B	Exterior Evaluation : E

<p>a : Cut, Fray d : Loose, Deformed k : Animal Hair s : Smell t : Cigarette Burns x : Defective y : Stain</p>

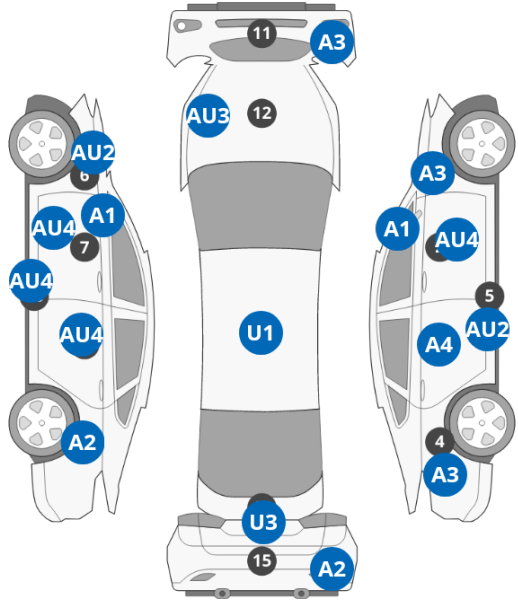
<p>A : Scratch AU : Scratch & Dent B : Modified C : Corrosion G : Stone chip P : Faded S : Rust SC : Rust & Corrosion U : Dent X : Defective Y : Crack, Gap</p>
<p>Remarks (R) Front Seat - Grime - Medium / (R) Front Trim - Grime - Small / Rear Seat - Grime - Medium / (L) Front Trim - Grime - Medium / (L) Front Seat - Grime - Small / Ceiling - Grime - Minimal</p>	<p>Remarks (L) Step, In-panel, Side Spoiler - Scratch & Dent - Large / (L) Rear Door, Molding - Scratch & Dent - Large / (L) Front Door, Molding - Scratch & Dent - Large / (L) Front Fender, Molding - Scratch & Dent - Small / (L) Mirror - Scratch - Minimal / (L) Rear Fender, Molding - Scratch - Small / Trunk Hood, Rear Gate - Dent - Medium / Rear Bumper, Lamps, Panels - Scratch - Small / (R) Rear Fender, Molding - Scratch - Medium / (R) Rear Door, Molding - Scratch - Large / (R) Front Door, Molding - Scratch & Dent - Large / (R) Step, In-panel, Side Spoiler - Scratch & Dent - Small / (R) Mirror - Scratch - Minimal / (R) Front Fender, Molding - Scratch - Medium / Roof - Dent - Minimal / Front Bumper, Grille, Lamps - Scratch - Medium / Bonnet, Headlight - Scratch & Dent - Medium</p>
