General Information

Make	Toyota	Model	Rush
YOM	2022	Odo Meter Reading	39,686
Registration No.	EAE8335	Chassis No.	MHKE8FF3PNK040736
CC	1.5	Transmission	A/T
Fuel Type	Gas	Type of Body	SUV
Colour	White

Body / Panel Condition

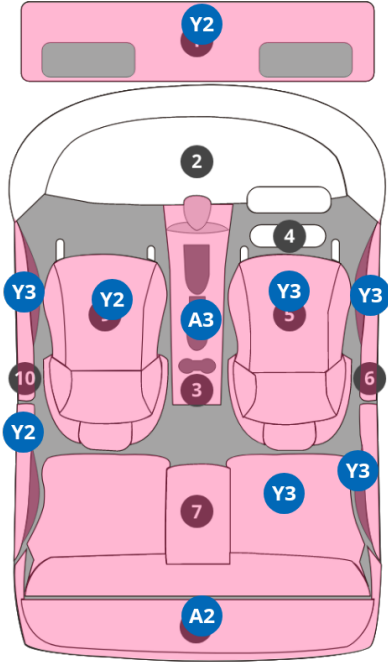
Interior Evaluation : D	Exterior Evaluation : C

<p>a : Cut, Fray d : Loose, Deformed k : Animal Hair s : Smell t : Cigarette Burns x : Defective y : Stain</p>

<p>A : Scratch AU : Scratch & Dent B : Modified C : Corrosion G : Stone chip P : Faded S : Rust SC : Rust & Corrosion U : Dent X : Defective Y : Crack, Gap</p>
Remarks (R) Front Seat - Grime - Medium / (R) Front Trim - Grime - Medium / Rear Seat - Grime - Medium / (R) Rear Trim - Grime - Medium / Trunk Room - Worn, Scratch, Cut, Crack - Small / (L) Rear Trim - Grime - Small / (L) Front Trim - Grime - Medium / (L) Front Seat - Grime - Small / Console, Switches, Vents - Worn, Scratch, Cut, Crack - Medium / Ceiling - Grime - Small	Remarks (L) Front Door, Molding - Scratch & Dent - Small / Bonnet, Headlight - Scratch - Small / Front Bumper, Grille, Lamps - Scratch - Medium / (R) Front Door, Molding - Scratch - Medium / (R) Rear Door, Molding - Scratch & Dent - Minimal / (R) Step, In-panel, Side Spoiler - Scratch - Small / (R) Rear Fender, Molding - Scratch & Dent - Minimal / Rear Bumper, Lamps, Panels - Scratch - Medium / Trunk Hood, Rear Gate - Scratch & Dent - Minimal / (L) Rear Fender, Molding - Scratch & Dent - Small / (L) Rear Door, Molding - Scratch & Dent - Medium / (L) Front Fender, Molding - Scratch - Minimal / Roof - Scratch - Minimal
