General Information

Make	Toyota	Model	Innova
YOM	2025	Odo Meter Reading	15,770
Registration No.	EAG8027	Chassis No.	PA2JA8EM0R0148870
CC	2.8	Transmission	A/T
Fuel Type	Diesel	Type of Body	Wagon
Colour	Red Mica Metallic

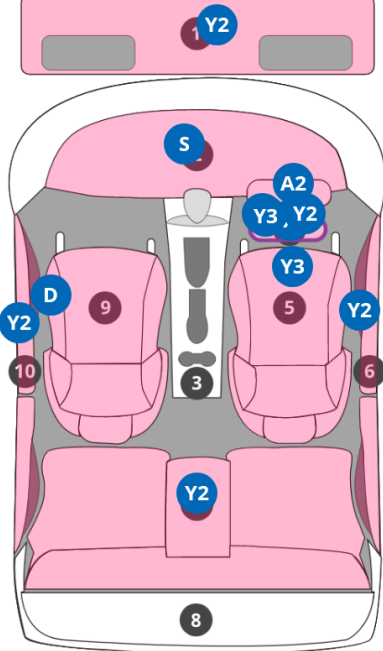
Interior Evaluation : C	Exterior Evaluation : D

<p>a : Cut, Fray d : Loose, Deformed k : Animal Hair s : Smell t : Cigarette Burns x : Defective y : Stain</p>

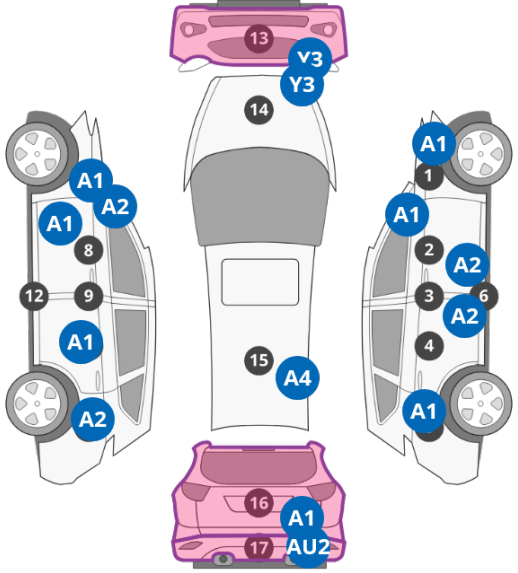
<p>A : Scratch AU : Scratch & Dent B : Modified C : Corrosion G : Stone chip P : Faded S : Rust SC : Rust & Corrosion U : Dent X : Defective Y : Crack, Gap</p>
<p>Remarks Overall Interior - Smell - Yes / (R) Front Seat - Grime - Medium / Glove Box - Worn, Scratch, Cut, Crack - Small / (L) Front Seat - Worn - Yes / Mat Other - Missing - Yes / (L) Front Floor Mat - Worked - Small / (R) Front Trim - Grime - Small / (L) Front Trim - Grime - Small / Ceiling - Grime - Small / Rear Seat - Grime - Small / (L) Front Floor Mat - Grime - Medium / (R) Front Floor Mat - Grime - Small</p>	<p>Remarks (L) Rear Fender - Repair Traces - Yes / Roof - Scratch - Large / (R) Front Fender, Molding - Scratch - Minimal / (R) Mirror - Scratch - Minimal / (R) Front Door, Molding - Scratch - Small / (R) Rear Door, Molding - Scratch - Small / (R) Rear Fender, Molding - Scratch - Minimal / Rear Bumper, Lamps, Panels - Repair mark - Yes / Rear Bumper, Lamps, Panels - Scratch & Dent - Small / Trunk Hood, Rear Gate - Repair mark - Yes / Trunk Hood, Rear Gate - Scratch - Minimal / (L) Rear Fender, Molding - Scratch - Small / (L) Rear Door, Molding - Scratch - Minimal / (L) Front Door, Molding - Scratch - Minimal / (L) Mirror - Scratch - Small / (L) Front Fender, Molding - Scratch - Minimal / Front Bumper, Grille, Lamps - Repair mark - Yes / Front Bumper, Grille, Lamps - Crack, Gap - Medium / Bonnet, Headlight - Crack, Gap - Medium</p>
