General Information

Make	Toyota	Model	Hilux Tamaraw
YOM	2025	Odo Meter Reading	16,269
Registration No.	NJC6259	Chassis No.	PAHACACA5S6424804
CC	2.4	Transmission	M/T
Fuel Type	Diesel	Type of Body	Utility Passenger
Colour	White

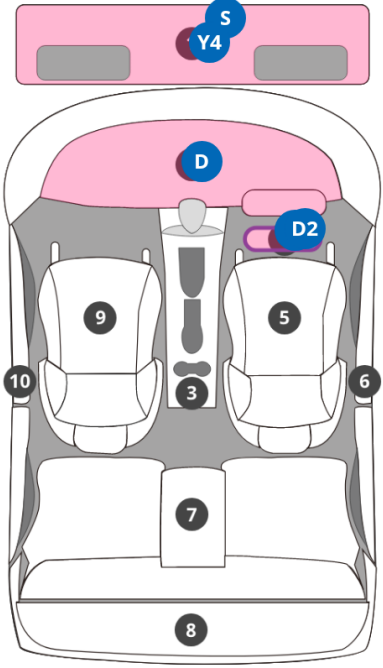
Interior Evaluation : C	Exterior Evaluation : D

<p>a : Cut, Fray d : Loose, Deformed k : Animal Hair s : Smell t : Cigarette Burns x : Defective y : Stain</p>

<p>A : Scratch AU : Scratch & Dent B : Modified C : Corrosion G : Stone chip P : Faded S : Rust SC : Rust & Corrosion U : Dent X : Defective Y : Crack, Gap</p>
<p>Remarks Overall Interior - Smell - Yes / Ceiling - Grime - Large / Dashboard - Traces of Adhesive Tape - Yes / Mat Other - Missing - Yes / (L) Front Floor Mat - Worked - Small</p>	<p>Remarks Front Bumper, Grille, Lamps - Scratch - Medium / (L) Front Fender, Molding - Scratch - Small / (L) Front Door, Molding - Scratch & Dent - Small / (L) Side Gate - Scratch & Dent - Small / Rear Gate - Scratch - Small / Rear Bumper, Lamps, Panels - Scratch & Dent - Small / (R) Side Gate - Scratch & Dent - Small / (R) Front Door, Molding - Scratch - Small / (R) Front Fender, Molding - Scratch - Small / Cargo Bed Floor - Scratch & Dent - Small / Roof - Scratch & Dent - Small / Bonnet, Headlight - Scratch - Small / (R) Mirror - Scratch - Minimal / (L) Mirror - Scratch - Minimal / (R) Step, In-panel, Side Spoiler - Scratch - Small / (L) Step, In-panel, Side Spoiler - Scratch & Dent - Small</p>
