## General Information

<b>Make</b>	Toyota	<b>Model</b>	Rush
<b>YOM</b>	2024	<b>Odo Meter Reading</b>	22,553
<b>Registration No.</b>	GBA8831	<b>Chassis No.</b>	MHKE8FF3PPK058017
<b>CC</b>	1.5	<b>Transmission</b>	A/T
<b>Fuel Type</b>	Gas	<b>Type of Body</b>	SUV
<b>Colour</b>	White

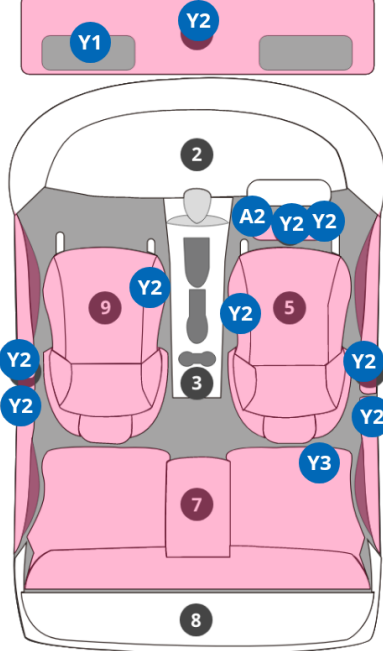
<b>Interior Evaluation :</b> <span style="color: red; font-weight: bold;">C</span>	<b>Exterior Evaluation :</b> <span style="color: red; font-weight: bold;">C</span>

<p><b>a</b> : Cut, Fray <b>d</b> : Loose, Deformed <b>k</b> : Animal Hair <b>s</b> : Smell <b>t</b> : Cigarette Burns <b>x</b> : Defective <b>y</b> : Stain</p>

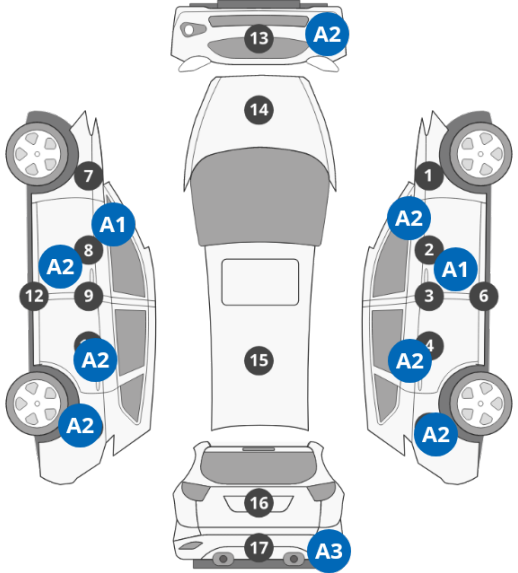
<p><b>A</b> : Scratch <b>AU</b> : Scratch &amp; Dent <b>B</b> : Modified <b>C</b> : Corrosion <b>G</b> : Stone chip <b>P</b> : Faded <b>S</b> : Rust <b>SC</b> : Rust &amp; Corrosion <b>U</b> : Dent <b>X</b> : Defective <b>Y</b> : Crack, Gap</p>
<p><b>Remarks</b> (L) Front Floor Mat - Cut, Crack - Small / Mat Other - Grime - Small / (L) Front Seat - Grime - Small / (L) Front Trim - Grime - Small / (L) Rear Trim - Grime - Small / (R) Rear Trim - Grime - Small / Rear Seat - Grime - Medium / (R) Front Trim - Grime - Small / (R) Front Seat - Grime - Small / (R) Front Floor Mat - Grime - Small / Sunvisor, Sunglass Holder - Grime - Minimal / Ceiling - Grime - Small</p>	<p><b>Remarks</b> (L) Mirror - Scratch - Minimal / (L) Front Door, Molding - Scratch - Small / (L) Rear Door, Molding - Scratch - Small / (L) Rear Fender, Molding - Scratch - Small / Rear Bumper, Lamps, Panels - Scratch - Medium / (R) Rear Fender, Molding - Scratch - Small / (R) Front Door, Molding - Scratch - Minimal / (R) Mirror - Scratch - Small / Front Bumper, Grille, Lamps - Scratch - Small / (R) Rear Door, Molding - Scratch - Small</p>
