## General Information

<b>Make</b>	Toyota	<b>Model</b>	Hilux
<b>YOM</b>	2025	<b>Odo Meter Reading</b>	9,996
<b>Registration No.</b>	BAG8248	<b>Chassis No.</b>	MR0JB8DD6R3553971
<b>CC</b>	2.4	<b>Transmission</b>	A/T
<b>Fuel Type</b>	Diesel	<b>Type of Body</b>	Pickup
<b>Colour</b>	Black

## Body / Panel Condition

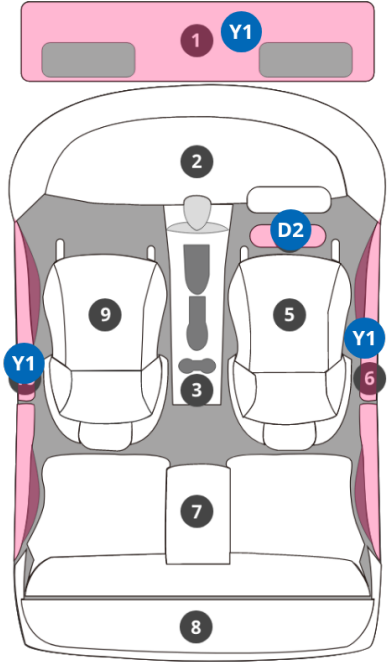
<b>Interior Evaluation :</b> <span style="float: right; color: red; font-weight: bold;">A</span>	<b>Exterior Evaluation :</b> <span style="float: right; color: red; font-weight: bold;">E</span>

<p><b>a</b> : Cut, Fray <b>d</b> : Loose, Deformed <b>k</b> : Animal Hair <b>s</b> : Smell <b>t</b> : Cigarette Burns <b>x</b> : Defective <b>y</b> : Stain</p>

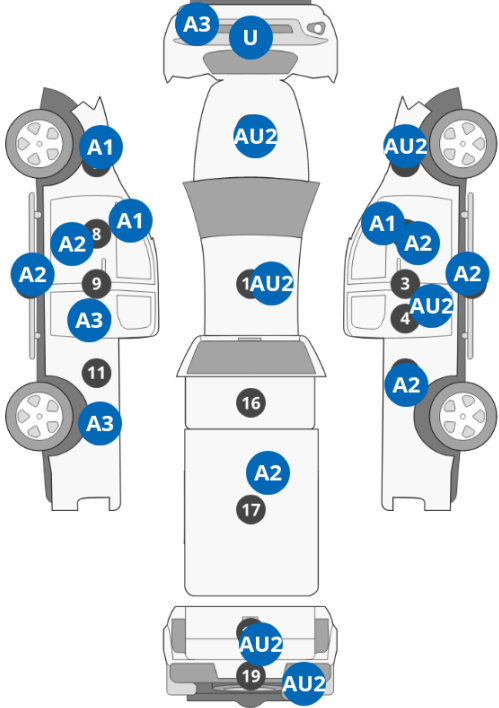
<p><b>A</b> : Scratch <b>AU</b> : Scratch &amp; Dent <b>B</b> : Modified <b>C</b> : Corrosion <b>G</b> : Stone chip <b>P</b> : Faded <b>S</b> : Rust <b>SC</b> : Rust &amp; Corrosion <b>U</b> : Dent <b>X</b> : Defective <b>Y</b> : Crack, Gap</p>
<p><b>Remarks</b> (L) Front Trim - Grime - Minimal / (R) Front Trim - Grime - Minimal / Ceiling - Grime - Minimal / (L) Front Floor Mat - Worked - Small</p>	<p><b>Remarks</b> (L) Rear Door, Molding - Scratch - Medium / (L) Side Gate - Scratch - Medium / Front Bumper, Grille, Lamps - Scratch - Medium / (L) Front Fender, Molding - Scratch - Minimal / (L) Front Door, Molding - Scratch - Small / (L) Step, In-panel, Side Spoiler - Scratch - Small / (L) Mirror - Scratch - Minimal / Bonnet, Headlight - Scratch &amp; Dent - Small / Roof - Scratch &amp; Dent - Small / Rear Gate - Scratch &amp; Dent - Small / Rear Bumper, Lamps, Panels - Scratch &amp; Dent - Small / Cargo Bed Floor - Scratch - Small / (R) Side Gate - Scratch - Small / (R) Rear Door, Molding - Scratch &amp; Dent - Small / (R) Step, In-panel, Side Spoiler - Scratch - Small / (R) Front Door, Molding - Scratch - Small / (R) Front Fender, Molding - Scratch &amp; Dent - Small / Member (Bolted) - Dent - Yes / (R) Mirror - Scratch - Minimal</p>

<p><b>Inspector Notes</b></p>
<p>With LTO plate and Sparetire, No Tools and Jack and Warranty booklet, No spare key, worn tires and Sparetire, Scratch and Crack Tail light and Headlight, foul smell, plate light issue and room light issue.</p>
