General Information

Make	Toyota	Model	Vios
YOM	2017	Odo Meter Reading	90,357
Registration No.	NBB6035	Chassis No.	PA1B19F3XH4043278
CC	1.3	Transmission	A/T
Fuel Type	Gas	Type of Body	Sedan
Colour	Green

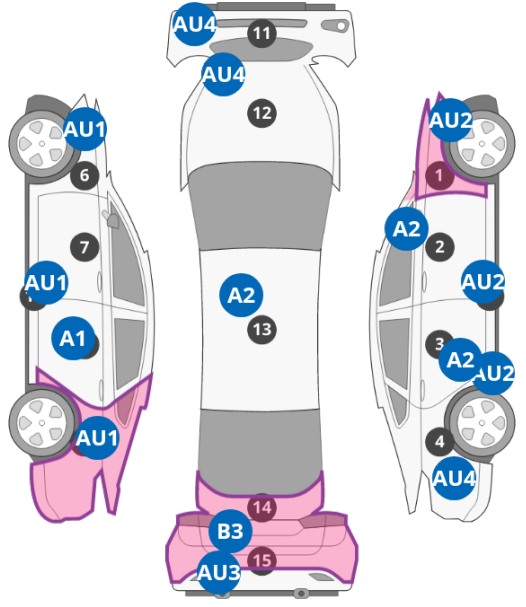
<p>A : Scratch AU : Scratch & Dent B : Modified C : Corrosion G : Stone chip P : Faded S : Rust SC : Rust & Corrosion U : Dent X : Defective Y : Crack, Gap</p>
Remarks Defects not found	Remarks (R) Front Fender, Molding - Repair mark - Yes / (R) Front Fender, Molding - Scratch & Dent - Small / (R) Mirror - Scratch - Small / (R) Front Door, Molding - Scratch & Dent - Small / (R) Step, In-panel, Side Spoiler - Scratch & Dent - Small / (R) Rear Door, Molding - Scratch - Small / (R) Rear Fender, Molding - Scratch & Dent - Large / Trunk Hood, Rear Gate - Repair mark - Yes / Trunk Hood, Rear Gate - Modified - Medium / Rear Bumper, Lamps, Panels - Scratch & Dent - Medium / (L) Rear Fender, Molding - Repair mark - Yes / (L) Rear Fender, Molding - Scratch & Dent - Minimal / (L) Rear Door, Molding - Scratch - Minimal / (L) Front Door, Molding - Scratch & Dent - Minimal / (L) Front Fender, Molding - Scratch & Dent - Minimal / Bonnet, Headlight - Scratch & Dent - Large / Front Bumper, Grille, Lamps - Scratch & Dent - Large / Roof - Scratch - Small

Inspector Notes
With Lto plate, with warranty booklet, with spare tire and jack, no tools, 1 key, scratches and cracks on headlight and taillight
