General Information

Make	Toyota	Model	Vios
YOM	2008	Odo Meter Reading	196,490
Registration No.	ZNJ772	Chassis No.	NCP929004385
CC	1.3	Transmission	M/T
Fuel Type	Gas	Type of Body	Sedan
Colour	Blue

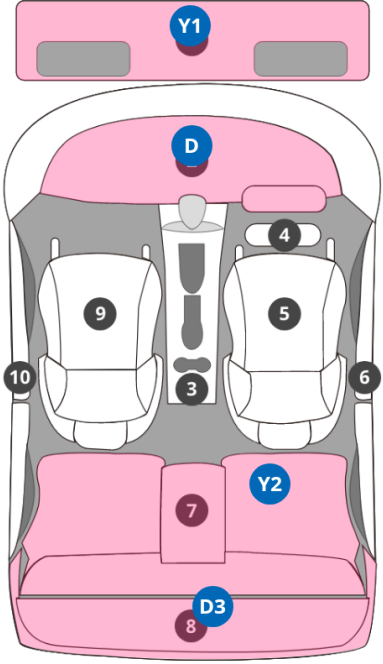
Interior Evaluation : B	Exterior Evaluation : E

<p>a : Cut, Fray d : Loose, Deformed k : Animal Hair s : Smell t : Cigarette Burns x : Defective y : Stain</p>

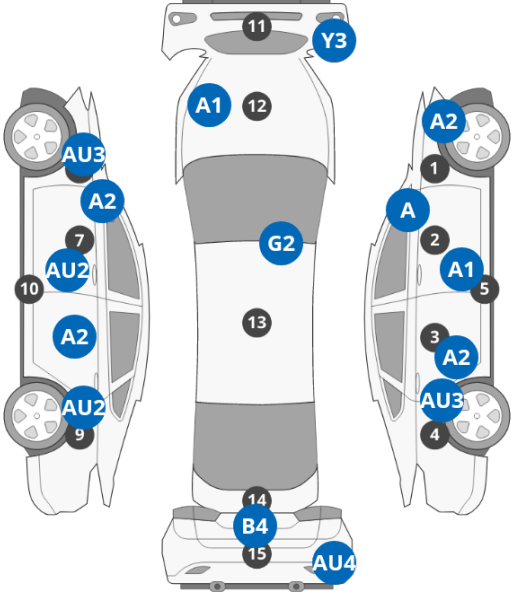
<p>A : Scratch AU : Scratch & Dent B : Modified C : Corrosion G : Stone chip P : Faded S : Rust SC : Rust & Corrosion U : Dent X : Defective Y : Crack, Gap</p>
<p>Remarks Sunvisor, Sunglass Holder - Grime - Minimal / Dashboard - Traces of Adhesive Tape - Yes / Rear Seat - Grime - Small / Trunk Room - Loose, Deformed - Medium</p>	<p>Remarks (R) Front Door - Repair Traces - Yes / (R) Step - Repair Traces - Yes / (R) Front Fender - Repair Traces - Yes / Bonnet - Repair Traces - Yes / (L) Front Fender - Repair Traces - Yes / (L) Front Door - Repair Traces - Yes / (L) Step - Repair Traces - Yes / (L) Rear Door - Repair Traces - Yes / (L) Rear Fender - Repair Traces - Yes / Trunk Hood, Rear Gate - Repair Traces - Yes / (R) Rear Fender - Repair Traces - Yes / (R) Rear Door - Repair Traces - Yes / Roof - Repair Traces - Yes / Overall Exterior - Full Re-Paint in same color - Yes / (R) Front Fender, Molding - Scratch - Small / (R) Mirror - Scratch, Peeled - Yes / (R) Front Door, Molding - Scratch - Minimal / (R) Rear Door, Molding - Scratch - Small / (R) Rear Fender, Molding - Scratch & Dent - Medium / Rear Bumper, Lamps, Panels - Scratch & Dent - Large / Trunk Hood, Rear Gate - Modified - Large / (L) Rear Fender, Molding - Scratch & Dent - Small / (L) Rear Door, Molding - Scratch - Small / (L) Front Door, Molding - Scratch & Dent - Small / (L) Mirror - Scratch - Small / (L) Front Fender, Molding - Scratch & Dent - Medium / Front Bumper, Grille, Lamps - Crack, Gap - Medium / Front Windshield - Scratch, Stone chip - Small / Bonnet, Headlight - Scratch - Minimal</p>
