General Information

Make	Toyota	Model	Corolla Altis
YOM	2008	Odo Meter Reading	271,032
Registration No.	ZTL216	Chassis No.	MR053ZEE108120756
CC	1.6	Transmission	A/T
Fuel Type	Gas	Type of Body	Sedan
Colour	Silver

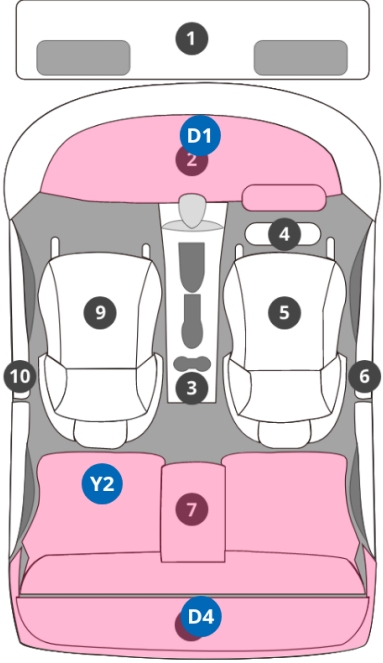
<p>a : Cut, Fray d : Loose, Deformed k : Animal Hair s : Smell t : Cigarette Burns x : Defective y : Stain</p>

<p>A : Scratch AU : Scratch & Dent B : Modified C : Corrosion G : Stone chip P : Faded S : Rust SC : Rust & Corrosion U : Dent X : Defective Y : Crack, Gap</p>
<p>Remarks Glove Box - Loose, Deformed - Minimal / Trunk Room - Loose, Deformed - Large / Rear Seat - Grime - Small</p>	<p>Remarks Overall Exterior - Full Re-Paint in same color - Yes / (R) Front Fender, Molding - Scratch - Minimal / Trunk Hood, Rear Gate - Scratch - Small / Rear Bumper, Lamps, Panels - Scratch - Small / (L) Step, In-panel, Side Spoiler - Scratch & Dent - Large / Bonnet, Headlight - Modified - Large / Front Bumper, Grille, Lamps - Scratch - Medium</p>
Frame Evaluation : A	Functional Evaluation : C
<p>Remarks Defects not found</p>	<p>Remarks Retractable Mirror - Issue - Yes / Warning Lamps - Issue - Yes / Audio, Radio - Issue - Yes / Spare Key - Issue - Unexist</p>

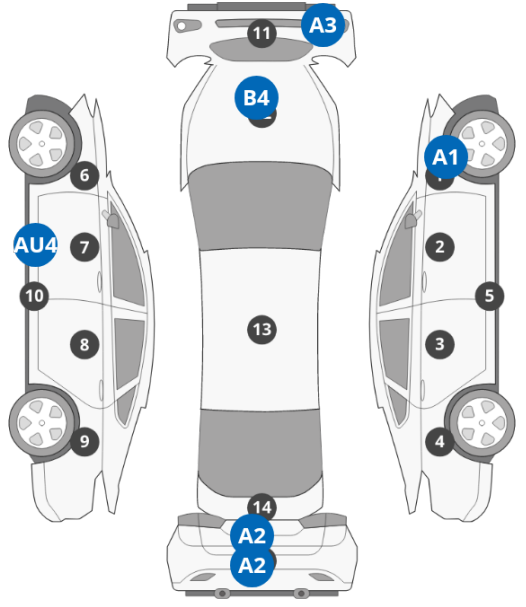
<p>Inspector Notes</p>
<p>With Lto plate, with spare and jack, 1key, no warranty booklet and tools,scratches on headlight and taillight, no trunk cover,</p>
