General Information

Make	Toyota	Model	Fortuner
YOM	2018	Odo Meter Reading	91,066
Registration No.	GAI8806	Chassis No.	MHFJB8GS0J1559262
CC	2.4	Transmission	A/T
Fuel Type	Diesel	Type of Body	SUV
Colour	White

Body / Panel Condition

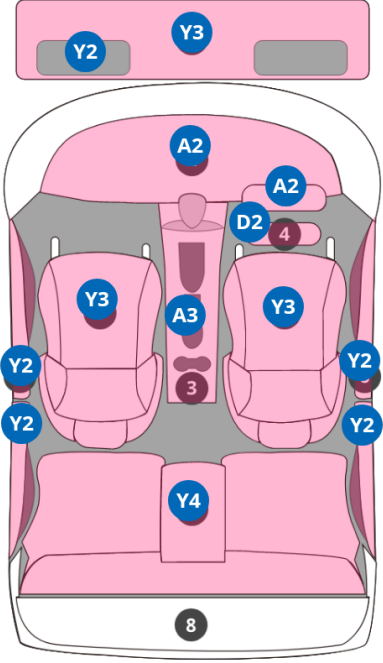
Interior Evaluation : E	Exterior Evaluation : E

<p>a : Cut, Fray d : Loose, Deformed k : Animal Hair s : Smell t : Cigarette Burns x : Defective y : Stain</p>

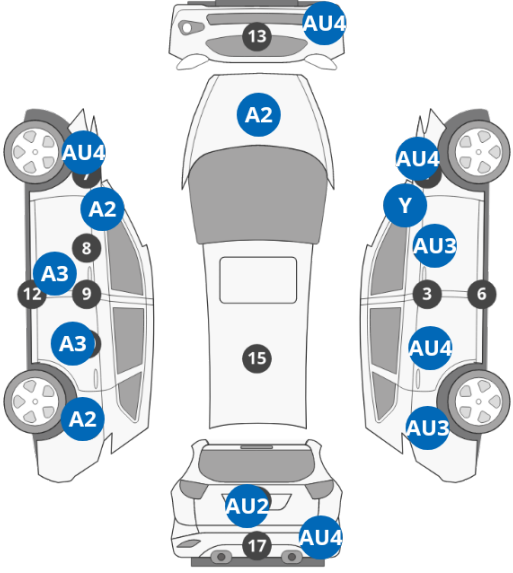
<p>A : Scratch AU : Scratch & Dent B : Modified C : Corrosion G : Stone chip P : Faded S : Rust SC : Rust & Corrosion U : Dent X : Defective Y : Crack, Gap</p>
<p>Remarks (L) Front Seat - Grime - Medium / Console, Switches, Vents - Worn, Scratch, Cut, Crack - Medium / Ceiling - Grime - Medium / Sunvisor, Sunglass Holder - Grime - Small / (L) Front Floor Mat - Worked - Small / Rear Seat - Grime - Large / (L) Front Trim - Grime - Small / (L) Rear Trim - Grime - Small / (R) Rear Trim - Grime - Small / (R) Front Seat - Grime - Medium / (R) Front Trim - Grime - Small / Dashboard - Worn, Scratch, Cut, Crack - Small / Steering Wheel - Worn, Peel, Crack - Small</p>	<p>Remarks Bonnet - Repair Traces - Yes / Trunk Hood, Rear Gate - Repair Traces - Yes / Front Bumper, Grille, Lamps - Scratch & Dent - Large / (R) Front Fender, Molding - Scratch & Dent - Large / (R) Mirror - Crack - Cracks / (R) Front Door, Molding - Scratch & Dent - Medium / (R) Rear Door, Molding - Scratch & Dent - Large / (R) Rear Fender, Molding - Scratch & Dent - Medium / Rear Bumper, Lamps, Panels - Scratch & Dent - Large / Trunk Hood, Rear Gate - Scratch & Dent - Small / (L) Rear Fender, Molding - Scratch - Small / (L) Rear Door, Molding - Scratch - Medium / (L) Front Door, Molding - Scratch - Medium / (L) Front Fender, Molding - Scratch & Dent - Large / (L) Mirror - Scratch - Small / Bonnet, Headlight - Scratch - Small</p>
