General Information

Make	Toyota	Model	Vios
YOM	2024	Odo Meter Reading	52,935
Registration No.	HAH1459	Chassis No.	PA1B18F36P4236794
CC	1.3	Transmission	CVT
Fuel Type	Gas	Type of Body	Sedan
Colour	White

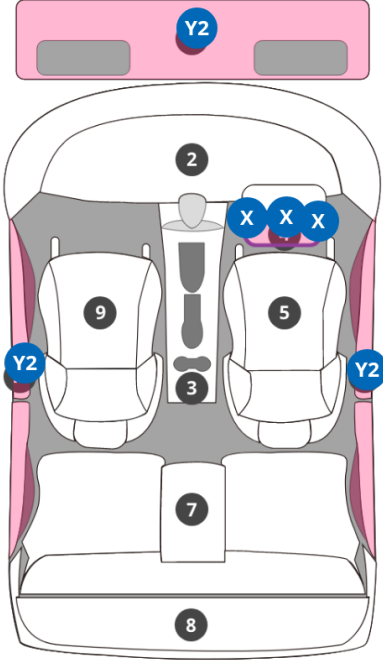
Interior Evaluation : B	Exterior Evaluation : D

<p>a : Cut, Fray d : Loose, Deformed k : Animal Hair s : Smell t : Cigarette Burns x : Defective y : Stain</p>

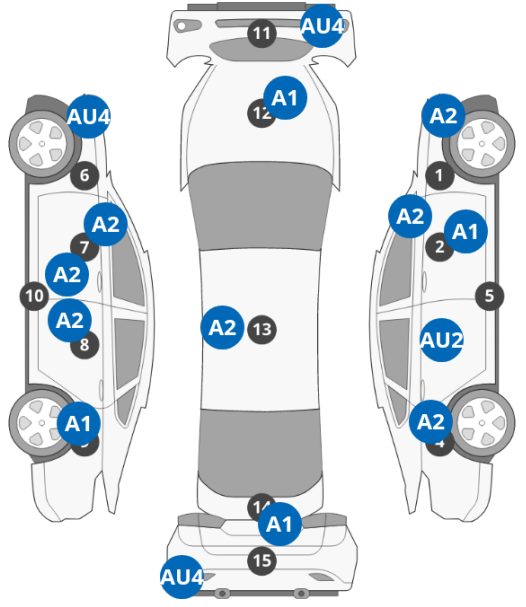
<p>A : Scratch AU : Scratch & Dent B : Modified C : Corrosion G : Stone chip P : Faded S : Rust SC : Rust & Corrosion U : Dent X : Defective Y : Crack, Gap</p>
<p>Remarks (R) Front Trim - Grime - Small / (R) Front Floor Mat - Missing - Yes / Ceiling - Grime - Small / Mat Other - Missing - Yes / (L) Front Trim - Grime - Small / (L) Front Floor Mat - Missing - Yes</p>	<p>Remarks (L) Front Fender, Molding - Scratch & Dent - Large / (L) Mirror - Scratch - Small / (L) Front Door, Molding - Scratch - Small / (L) Rear Door, Molding - Scratch - Small / (L) Rear Fender, Molding - Scratch - Minimal / (R) Rear Door, Molding - Scratch & Dent - Small / (R) Rear Fender, Molding - Scratch - Small / Rear Bumper, Lamps, Panels - Scratch & Dent - Large / Trunk Hood, Rear Gate - Scratch - Minimal / (R) Mirror - Scratch - Small / (R) Front Door, Molding - Scratch - Minimal / (R) Front Fender, Molding - Scratch - Small / Bonnet, Headlight - Scratch - Minimal / Front Bumper, Grille, Lamps - Scratch & Dent - Large / Roof - Scratch - Small</p>
