General Information

Make	Toyota	Model	Veloz
YOM	2023	Odo Meter Reading	146,725
Registration No.	NEE9690	Chassis No.	MHFAB1BY9N3D45715
CC	1.5	Transmission	CVT
Fuel Type	Gas	Type of Body	SUV
Colour	Pearl White

Body / Panel Condition

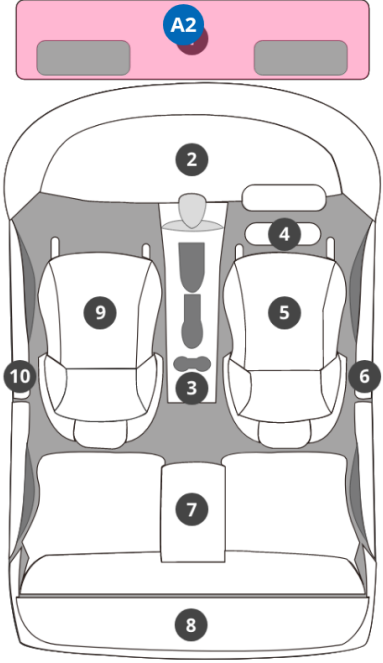
Interior Evaluation : A	Exterior Evaluation : C

<p>a : Cut, Fray d : Loose, Deformed k : Animal Hair s : Smell t : Cigarette Burns x : Defective y : Stain</p>

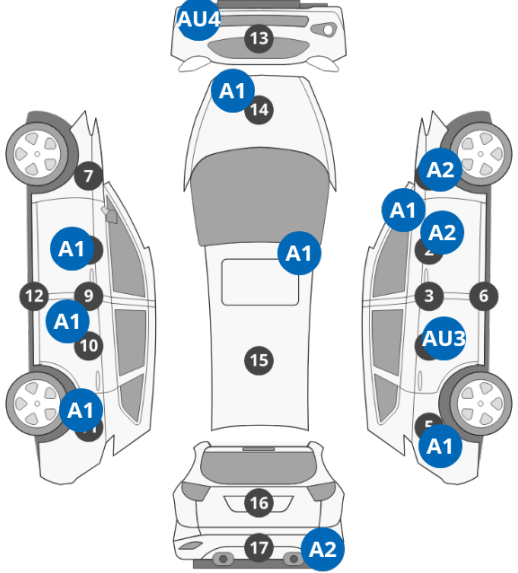
<p>A : Scratch AU : Scratch & Dent B : Modified C : Corrosion G : Stone chip P : Faded S : Rust SC : Rust & Corrosion U : Dent X : Defective Y : Crack, Gap</p>
Remarks Ceiling - Cut, Crack - Small	Remarks (R) Front Fender, Molding - Scratch - Small / (R) Mirror - Scratch - Minimal / (R) Front Door, Molding - Scratch - Small / (R) Rear Door, Molding - Scratch & Dent - Medium / (R) Rear Fender, Molding - Scratch - Minimal / Rear Bumper, Lamps, Panels - Scratch - Small / (L) Rear Fender, Molding - Scratch - Minimal / (L) Rear Door, Molding - Scratch - Minimal / (L) Front Door, Molding - Scratch - Minimal / Front Bumper, Grille, Lamps - Scratch & Dent - Large / Bonnet, Headlight - Scratch - Minimal / Roof - Scratch - Minimal
Frame Evaluation : A	Functional Evaluation : A

Inspector Notes
With Lto plate, with warranty booklet, with spare tire and jack, 1key, no tools,scratches on headlight and taillight
