General Information

Make	Toyota	Model	Wigo
YOM	2021	Odo Meter Reading	55,628
Registration No.	NDZ8121	Chassis No.	MHKA4DF5FMJ056082
CC	1.0	Transmission	A/T
Fuel Type	Gas	Type of Body	Hatchback
Colour	Orange

Body / Panel Condition

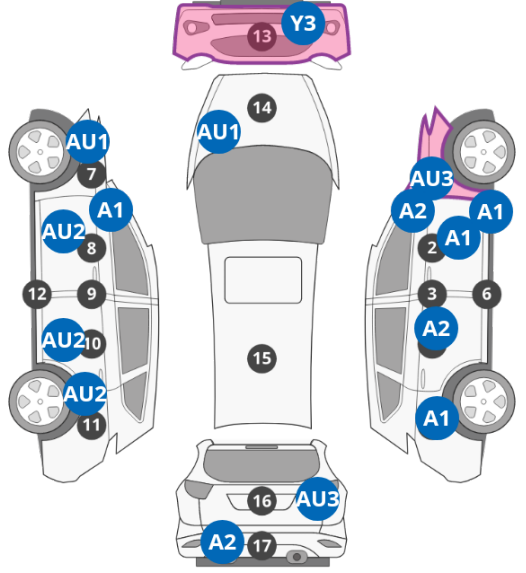
<p>A : Scratch AU : Scratch & Dent B : Modified C : Corrosion G : Stone chip P : Faded S : Rust SC : Rust & Corrosion U : Dent X : Defective Y : Crack, Gap</p>
<p>Remarks Dashboard - Traces of Adhesive Tape - Yes / (R) Front Seat - Grime - Minimal / Rear Seat - Grime - Minimal / Ceiling - Grime - Minimal</p>	<p>Remarks (R) Front Fender - Repair Traces - Yes / (R) Front Fender, Molding - Repair mark - Difference in Color / (R) Front Fender, Molding - Scratch & Dent - Medium / (R) Mirror - Scratch - Small / (R) Front Door, Molding - Scratch - Minimal / (R) Step, In-panel, Side Spoiler - Scratch - Minimal / (R) Rear Door, Molding - Scratch - Small / (R) Rear Fender, Molding - Scratch - Minimal / Trunk Hood, Rear Gate - Scratch & Dent - Medium / Rear Bumper, Lamps, Panels - Scratch - Small / (L) Rear Fender, Molding - Scratch & Dent - Small / (L) Rear Door, Molding - Scratch & Dent - Small / (L) Front Door, Molding - Scratch & Dent - Small / (L) Mirror - Scratch - Minimal / (L) Front Fender, Molding - Scratch & Dent - Minimal / Bonnet, Headlight - Scratch & Dent - Minimal / Front Bumper, Grille, Lamps - Repair mark - Yes / Front Bumper, Grille, Lamps - Crack, Gap - Medium</p>
