General Information

Make	Toyota	Model	Hiace
YOM	2023	Odo Meter Reading	36,372
Registration No.	NII6257	Chassis No.	JTFNAFAP9NN8030258
CC	2.8	Transmission	M/T
Fuel Type	Diesel	Type of Body	Van
Colour	Silver

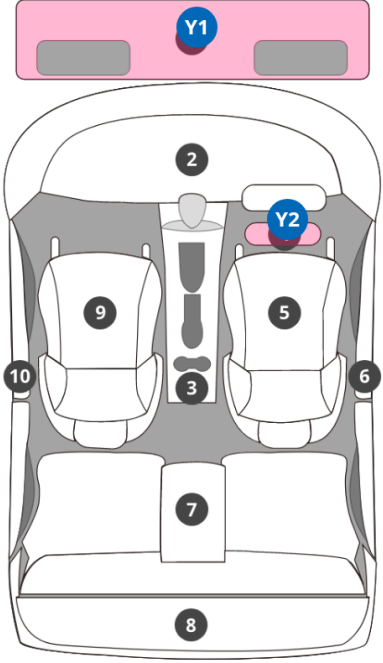
Interior Evaluation : A	Exterior Evaluation : E

<p>a : Cut, Fray d : Loose, Deformed k : Animal Hair s : Smell t : Cigarette Burns x : Defective y : Stain</p>

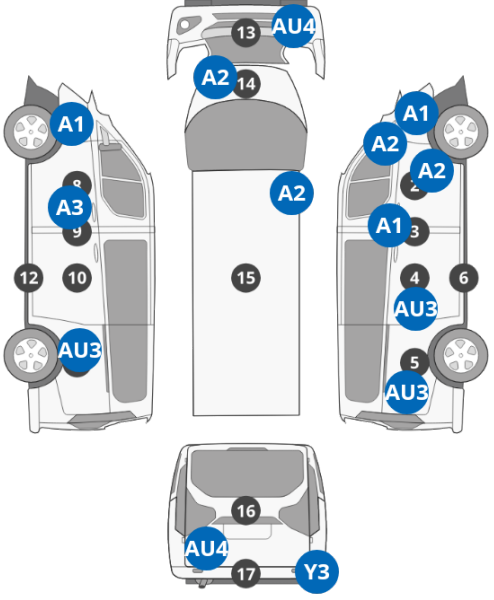
<p>A : Scratch AU : Scratch & Dent B : Modified C : Corrosion G : Stone chip P : Faded S : Rust SC : Rust & Corrosion U : Dent X : Defective Y : Crack, Gap</p>
<p>Remarks (L) Front Floor Mat - Grime - Small / Ceiling - Grime - Minimal</p>	<p>Remarks (R) Front Fender, Molding - Scratch - Minimal / (R) Mirror - Scratch - Small / (R) Front Door, Molding - Scratch - Small / (R) Center Panel - Scratch - Minimal / (R) Rear Door, Molding - Scratch & Dent - Medium / (R) Rear Fender, Molding - Scratch & Dent - Medium / Trunk Hood, Rear Gate - Scratch & Dent - Large / Rear Bumper, Lamps, Panels - Crack, Gap - Medium / (L) Rear Fender, Molding - Scratch & Dent - Medium / (L) Front Door, Molding - Scratch - Medium / (L) Front Fender, Molding - Scratch - Minimal / Bonnet, Headlight - Scratch - Small / Front Bumper, Grille, Lamps - Scratch & Dent - Large / Roof - Scratch - Small</p>
