General Information

Make	Toyota	Model	Vios
YOM	2022	Odo Meter Reading	35,087
Registration No.	CBD8930	Chassis No.	PA1B18F37N4154704
CC	1.3	Transmission	CVT
Fuel Type	Gas	Type of Body	Sedan
Colour	Blue

Body / Panel Condition

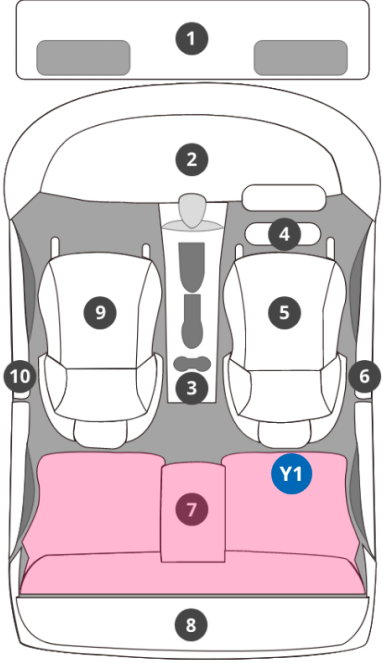
Interior Evaluation : A	Exterior Evaluation : B

<p>a : Cut, Fray d : Loose, Deformed k : Animal Hair s : Smell t : Cigarette Burns x : Defective y : Stain</p>

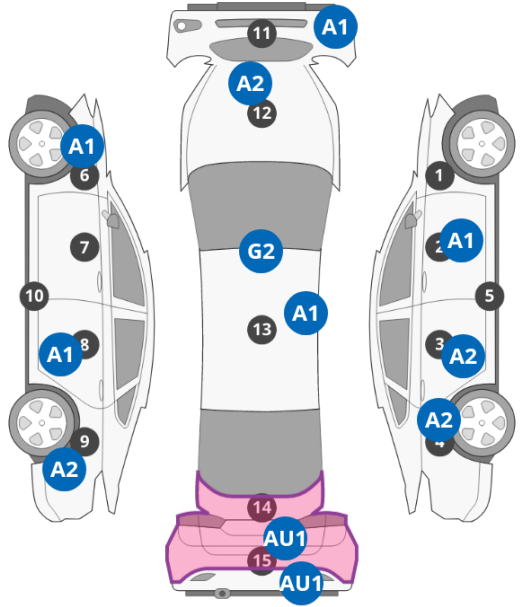
<p>A : Scratch AU : Scratch & Dent B : Modified C : Corrosion G : Stone chip P : Faded S : Rust SC : Rust & Corrosion U : Dent X : Defective Y : Crack, Gap</p>
<p>Remarks Rear Seat - Grime - Minimal</p>	<p>Remarks Trunk Hood, Rear Gate - Repair Traces - Yes / (R) Front Door, Molding - Scratch - Minimal / (R) Rear Door, Molding - Scratch - Small / (R) Rear Fender, Molding - Scratch - Small / Trunk Hood, Rear Gate - Repair mark - Yes / Trunk Hood, Rear Gate - Scratch & Dent - Minimal / Rear Bumper, Lamps, Panels - Scratch & Dent - Minimal / (L) Rear Fender, Molding - Scratch - Small / (L) Rear Door, Molding - Scratch - Minimal / Bonnet, Headlight - Scratch - Small / (L) Front Fender, Molding - Scratch - Minimal / Front Bumper, Grille, Lamps - Scratch - Minimal / Roof - Scratch - Minimal / Front Windshield - Scratch, Stone chip - Small</p>

<p>Inspector Notes</p>
<p>With Lto plate, with jack and tools, 1key, no warranty booklet and spare tire, scratches on headlights and taillight</p>
