General Information

Make	Toyota	Model	Avanza
YOM	2023	Odo Meter Reading	36,046
Registration No.	NHA2743	Chassis No.	MHFAA1BY4P0016047
CC	1.3	Transmission	M/T
Fuel Type	Gas	Type of Body	MPV
Colour	Black

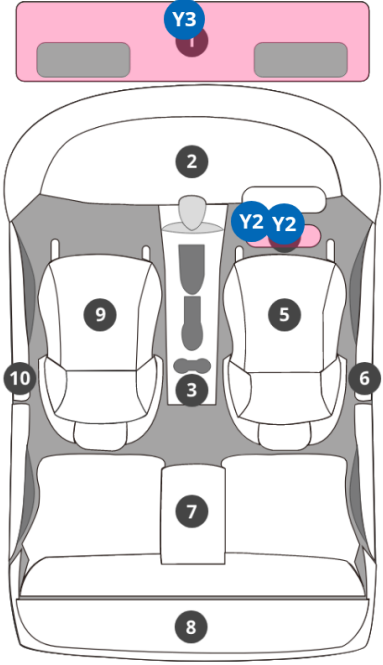
Interior Evaluation : B	Exterior Evaluation : E

<p>a : Cut, Fray d : Loose, Deformed k : Animal Hair s : Smell t : Cigarette Burns x : Defective y : Stain</p>

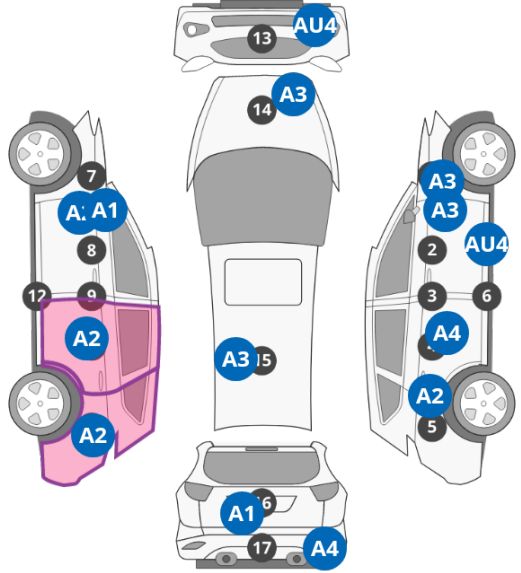
<p>A : Scratch AU : Scratch & Dent B : Modified C : Corrosion G : Stone chip P : Faded S : Rust SC : Rust & Corrosion U : Dent X : Defective Y : Crack, Gap</p>
<p>Remarks Mat Other - Grime - Small / Ceiling - Grime - Medium / (L) Front Floor Mat - Grime - Small</p>	<p>Remarks (L) Rear Fender - Repair Traces - Yes / (R) Front Fender, Molding - Scratch - Medium / (R) Front Door, Molding - Scratch - Medium / (R) Step, In-panel, Side Spoiler - Scratch & Dent - Large / (R) Rear Door, Molding - Scratch - Large / (R) Rear Fender, Molding - Scratch - Small / Rear Bumper, Lamps, Panels - Scratch - Large / Trunk Hood, Rear Gate - Scratch - Minimal / (L) Rear Fender, Molding - Repair mark - Difference in Color / (L) Rear Fender, Molding - Scratch - Small / (L) Rear Door, Molding - Repair mark - Difference in Color / (L) Rear Door, Molding - Scratch - Small / (L) Front Door, Molding - Scratch - Small / (L) Mirror - Scratch - Minimal / Front Bumper, Grille, Lamps - Scratch & Dent - Large / Bonnet, Headlight - Scratch - Medium / Roof - Scratch - Medium</p>
