General Information

Make	Mitsubishi	Model	Montero SPT
YOM	2023	Odo Meter Reading	118,090
Registration No.	CBD7867	Chassis No.	MMBGJKR10PH001950
CC	2.4	Transmission	M/T
Fuel Type	Diesel	Type of Body	SUV
Colour	Black

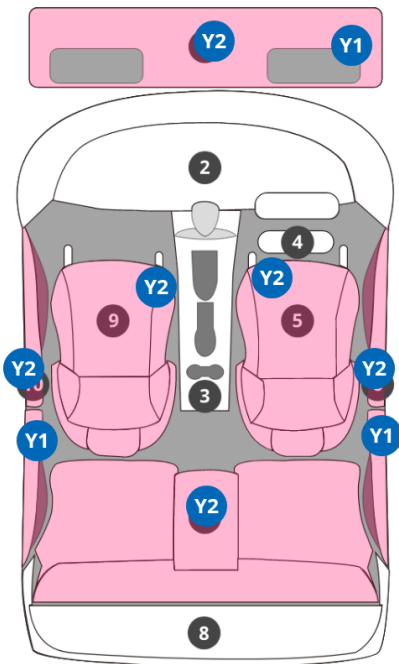
Interior Evaluation : B	Exterior Evaluation : C

<p>a : Cut, Fray d : Loose, Deformed k : Animal Hair s : Smell t : Cigarette Burns x : Defective y : Stain</p>

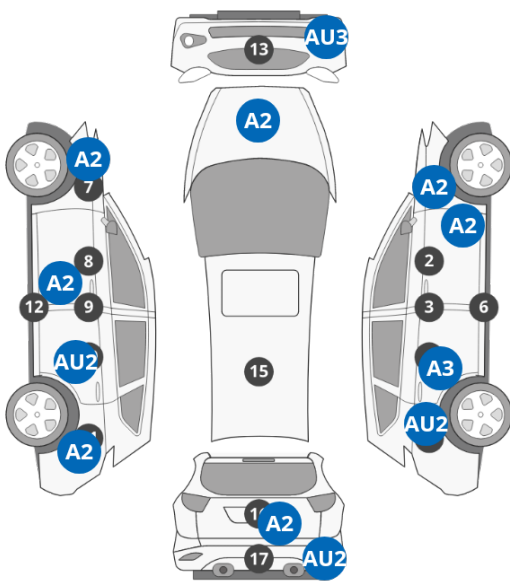
<p>A : Scratch AU : Scratch & Dent B : Modified C : Corrosion G : Stone chip P : Faded S : Rust SC : Rust & Corrosion U : Dent X : Defective Y : Crack, Gap</p>
<p>Remarks (R) Front Seat - Grime - Small / (R) Front Trim - Grime - Small / Ceiling - Grime - Small / Sunvisor, Sunglass Holder - Grime - Minimal / Rear Seat - Grime - Small / (R) Rear Trim - Grime - Minimal / (L) Rear Trim - Grime - Minimal / (L) Front Trim - Grime - Small / (L) Front Seat - Grime - Small</p>	<p>Remarks (L) Front Door - Repair Traces - Yes / (L) Rear Door - Repair Traces - Yes / (L) Front Fender, Molding - Scratch - Small / (L) Rear Door, Molding - Scratch & Dent - Small / (L) Front Door, Molding - Scratch - Small / (L) Rear Fender, Molding - Scratch - Small / (R) Rear Fender, Molding - Scratch & Dent - Small / Trunk Hood, Rear Gate - Scratch - Small / Rear Bumper, Lamps, Panels - Scratch & Dent - Small / (R) Rear Door, Molding - Scratch - Medium / (R) Front Fender, Molding - Scratch - Small / (R) Front Door, Molding - Scratch - Small / Front Bumper, Grille, Lamps - Scratch & Dent - Medium / Bonnet, Headlight - Scratch - Small</p>
