## General Information

<b>Make</b>	Toyota	<b>Model</b>	Wigo
<b>YOM</b>	2021	<b>Odo Meter Reading</b>	84,760
<b>Registration No.</b>	BAE8302	<b>Chassis No.</b>	MHKA4D5FMJ057275
<b>CC</b>	1.0	<b>Transmission</b>	A/T
<b>Fuel Type</b>	Gas	<b>Type of Body</b>	Hatchback
<b>Colour</b>	Orange

## Body / Panel Condition

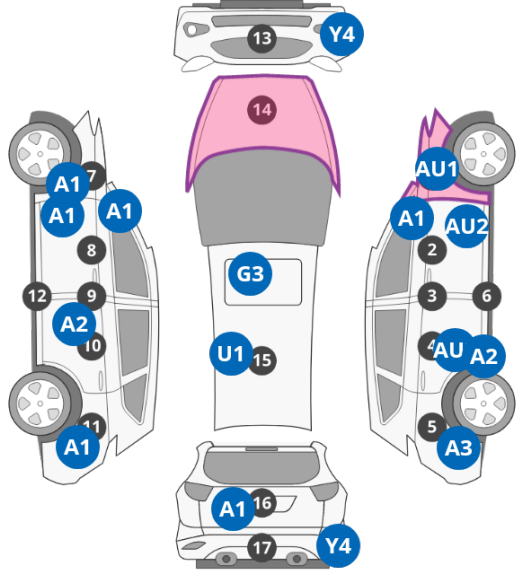
<p><b>A</b> : Scratch <b>AU</b> : Scratch &amp; Dent <b>B</b> : Modified <b>C</b> : Corrosion <b>G</b> : Stone chip <b>P</b> : Faded <b>S</b> : Rust <b>SC</b> : Rust &amp; Corrosion <b>U</b> : Dent <b>X</b> : Defective <b>Y</b> : Crack, Gap</p>
<b>Remarks</b> Ceiling - Grime - Small	<b>Remarks</b> (R) Front Fender - Repair Traces - Yes / Bonnet - Repair Traces - Yes / (R) Front Fender, Molding - Repair mark - Yes / (R) Front Fender, Molding - Scratch & Dent - Minimal / (R) Mirror - Scratch - Minimal / (R) Front Door, Molding - Scratch & Dent - Small / (R) Rear Door, Molding - Scratch & Dent - Medium / (R) Step, In-panel, Side Spoiler - Scratch - Small / (R) Rear Fender, Molding - Scratch - Medium / Rear Bumper, Lamps, Panels - Crack, Gap - Large / Trunk Hood, Rear Gate - Scratch - Minimal / (L) Rear Fender, Molding - Scratch - Minimal / (L) Rear Door, Molding - Scratch - Small / (L) Front Door, Molding - Scratch - Minimal / (L) Mirror - Scratch - Minimal / (L) Front Fender, Molding - Scratch - Minimal / Front Bumper, Grille, Lamps - Crack, Gap - Large / Front Windshield - Scratch, Stone chip - Medium / Bonnet, Headlight - Repair mark - Yes / Roof - Dent - Minimal

<b>Inspector Notes</b>
with Lto plate, with jack, 1key, no tools, spare tire issue, scratches on taillights, headlights issue, aircon issue,
