## General Information

<b>Make</b>	Kia	<b>Model</b>	Rio
<b>YOM</b>	2018	<b>Odo Meter Reading</b>	44,632
<b>Registration No.</b>	FAE1050	<b>Chassis No.</b>	KNADB514BJ6158109
<b>CC</b>	1.4	<b>Transmission</b>	A/T
<b>Fuel Type</b>	Gas	<b>Type of Body</b>	Hatchback
<b>Colour</b>	Red

## Body / Panel Condition

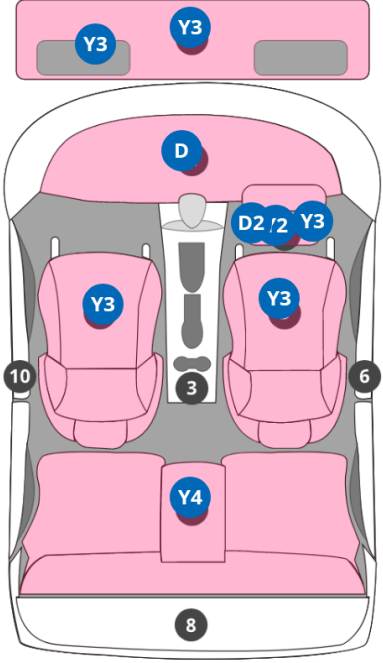
<b>Interior Evaluation :</b> <span style="float: right; color: red; font-weight: bold;">D</span>	<b>Exterior Evaluation :</b> <span style="float: right; color: red; font-weight: bold;">E</span>

<p><b>a</b> : Cut, Fray <b>d</b> : Loose, Deformed <b>k</b> : Animal Hair <b>s</b> : Smell <b>t</b> : Cigarette Burns <b>x</b> : Defective <b>y</b> : Stain</p>

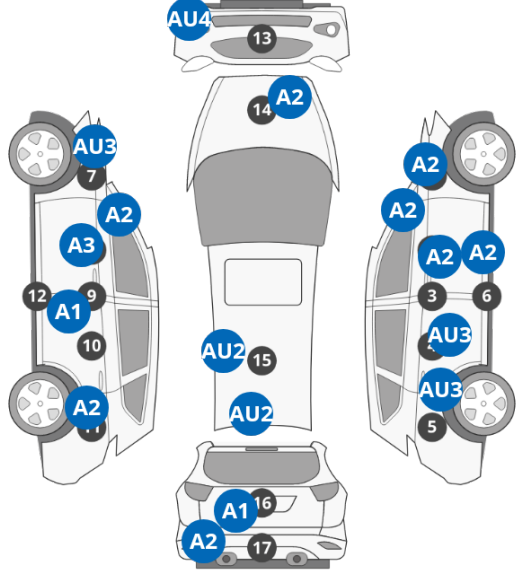
<p><b>A</b> : Scratch <b>AU</b> : Scratch &amp; Dent <b>B</b> : Modified <b>C</b> : Corrosion <b>G</b> : Stone chip <b>P</b> : Faded <b>S</b> : Rust <b>SC</b> : Rust &amp; Corrosion <b>U</b> : Dent <b>X</b> : Defective <b>Y</b> : Crack, Gap</p>
<p><b>Remarks</b>  Dashboard - Traces of Adhesive Tape - Yes / (R) Front Seat - Grime - Medium / (R) Front Floor Mat - Grime - Medium / Rear Seat - Grime - Large / Ceiling - Grime - Medium / Mat Other - Grime - Small / (L) Front Seat - Grime - Medium / (L) Front Floor Mat - Worked - Small / Sunvisor, Sunglass Holder - Grime - Medium</p>	<p><b>Remarks</b>  Bonnet - Repair Traces - Yes / (L) Front Door - Repair Traces - Yes / (L) Rear Door - Repair Traces - Yes / (R) Rear Fender - Repair Traces - Yes / (L) Front Fender, Molding - Scratch &amp; Dent - Medium / (L) Mirror - Scratch - Small / Bonnet, Headlight - Scratch - Small / Front Bumper, Grille, Lamps - Scratch &amp; Dent - Large / (L) Front Door, Molding - Scratch - Medium / (L) Rear Door, Molding - Scratch - Minimal / (L) Rear Fender, Molding - Scratch - Small / Roof - Scratch &amp; Dent - Small / Roof Spoiler, Molding - Scratch &amp; Dent - Small / Rear Bumper, Lamps, Panels - Scratch - Small / Trunk Hood, Rear Gate - Scratch - Minimal / (R) Rear Fender, Molding - Scratch &amp; Dent - Medium / (R) Rear Door, Molding - Scratch &amp; Dent - Medium / (R) Step, In-panel, Side Spoiler - Scratch - Small / (R) Front Door, Molding - Scratch - Small / (R) Mirror - Scratch - Small / (R) Front Fender, Molding - Scratch - Small</p>
