## General Information

<b>Make</b>	Toyota	<b>Model</b>	Vios
<b>YOM</b>	2026	<b>Odo Meter Reading</b>	2,682
<b>Registration No.</b>	CCQ4676	<b>Chassis No.</b>	PA1B18F32S4296094
<b>CC</b>	1.3	<b>Transmission</b>	CVT
<b>Fuel Type</b>	Gas	<b>Type of Body</b>	Sedan
<b>Colour</b>	Blue

## Body / Panel Condition

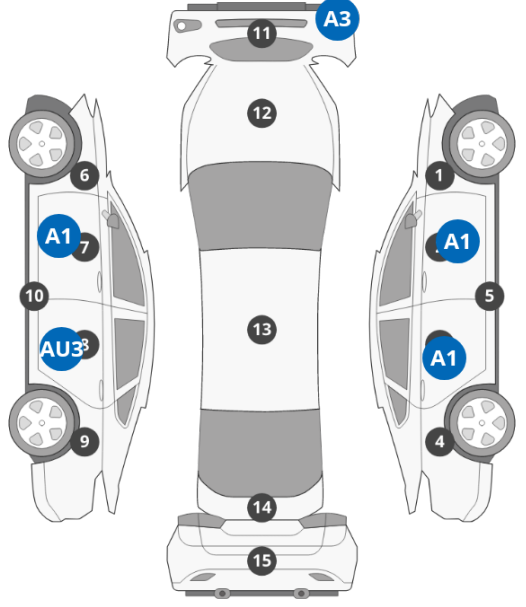
<b>Interior Evaluation :</b>	<b>A</b>	<b>Exterior Evaluation :</b>	<b>B</b>

<p><b>a</b> : Cut, Fray <b>d</b> : Loose, Deformed <b>k</b> : Animal Hair <b>s</b> : Smell <b>t</b> : Cigarette Burns <b>x</b> : Defective <b>y</b> : Stain</p>		<p><b>A</b> : Scratch <b>AU</b> : Scratch &amp; Dent <b>B</b> : Modified <b>C</b> : Corrosion <b>G</b> : Stone chip <b>P</b> : Faded <b>S</b> : Rust <b>SC</b> : Rust &amp; Corrosion <b>U</b> : Dent <b>X</b> : Defective <b>Y</b> : Crack, Gap</p>	
<p><b>Remarks</b> Defects not found</p>		<p><b>Remarks</b> (R) Front Door, Molding - Scratch - Minimal / (R) Rear Door, Molding - Scratch - Minimal / (L) Rear Door, Molding - Scratch &amp; Dent - Medium / (L) Front Door, Molding - Scratch - Minimal / Front Bumper, Grille, Lamps - Scratch - Medium</p>	
<b>Frame Evaluation :</b>	<b>A</b>	<b>Functional Evaluation :</b>	<b>A</b>
<p><b>Remarks</b> Defects not found</p>		<p><b>Remarks</b> Spare Key - Issue - Unexist</p>

<b>Inspector Notes</b>
No Lto plate, with spare tire, with jack and tools,1key, no warranty booklet, scratches on headlight and taillight
