General Information

Make	Toyota	Model	Wigo
YOM	2021	Odo Meter Reading	37,845
Registration No.	NEV5651	Chassis No.	MHKAADF5FMJ056366
CC	1.0	Transmission	A/T
Fuel Type	Gas	Type of Body	Hatchback
Colour	Orange

Body / Panel Condition

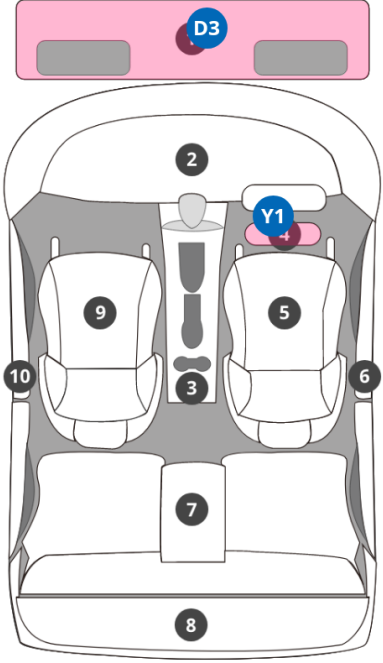
Interior Evaluation : B	Exterior Evaluation : B

<p>a : Cut, Fray d : Loose, Deformed k : Animal Hair s : Smell t : Cigarette Burns x : Defective y : Stain</p>

<p>A : Scratch AU : Scratch & Dent B : Modified C : Corrosion G : Stone chip P : Faded S : Rust SC : Rust & Corrosion U : Dent X : Defective Y : Crack, Gap</p>
Remarks Ceiling - Loose, Deformed - Medium / (L) Front Floor Mat - Grime - Minimal	Remarks (R) Front Fender - Repair Traces - Yes / Bonnet - Repair Traces - Yes / (L) Front Fender - Repair Traces - Yes / (L) Front Door - Repair Traces - Yes / (R) Front Fender, Molding - Repair mark - Yes / (R) Step, In-panel, Side Spoiler - Scratch - Minimal / (R) Rear Door, Molding - Scratch & Dent - Minimal / (R) Rear Fender, Molding - Dent - Minimal / Rear Bumper, Lamps, Panels - Scratch - Minimal / (L) Rear Fender, Molding - Scratch - Minimal / (L) Rear Door, Molding - Scratch - Minimal / (L) Front Fender, Molding - Repair mark - Yes / Front Bumper, Grille, Lamps - Scratch - Small
