General Information

Make	Toyota	Model	Vios
YOM	2018	Odo Meter Reading	37,825
Registration No.	FAD6493	Chassis No.	PA1B19F39J4060210
CC	1.3	Transmission	M/T
Fuel Type	Gas	Type of Body	Sedan
Colour	Green

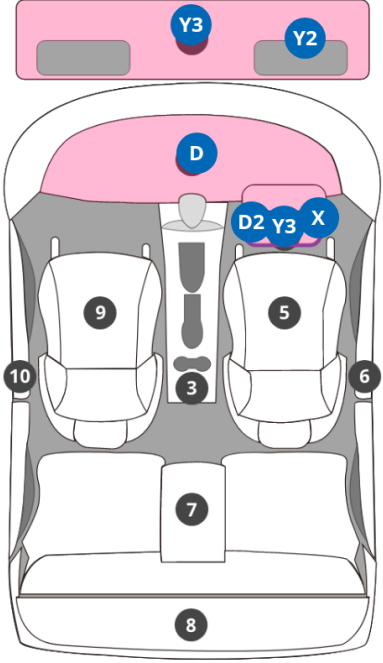
Interior Evaluation : B	Exterior Evaluation : D

<p>a : Cut, Fray d : Loose, Deformed k : Animal Hair s : Smell t : Cigarette Burns x : Defective y : Stain</p>

<p>A : Scratch AU : Scratch & Dent B : Modified C : Corrosion G : Stone chip P : Faded S : Rust SC : Rust & Corrosion U : Dent X : Defective Y : Crack, Gap</p>
<p>Remarks (R) Front Floor Mat - Missing - Yes / Dashboard - Traces of Adhesive Tape - Yes / Mat Other - Grime - Medium / (L) Front Floor Mat - Worked - Small / Ceiling - Grime - Medium / Sunvisor, Sunglass Holder - Grime - Small</p>	<p>Remarks (R) Front Door - Repair Traces - Yes / (L) Rear Door - Repair Traces - Yes / (L) Rear Fender - Repair Traces - Yes / (R) Rear Door, Molding - Scratch & Dent - Small / (R) Rear Fender, Molding - Scratch - Small / (R) Mirror - Scratch - Minimal / (R) Front Door, Molding - Scratch - Small / Rear Bumper, Lamps, Panels - Scratch & Dent - Large / Trunk Hood, Rear Gate - Scratch - Small / (L) Rear Fender, Molding - Scratch - Small / (L) Front Door, Molding - Scratch - Small / (L) Rear Door, Molding - Scratch - Small / (L) Mirror - Scratch - Minimal / Bonnet, Headlight - Scratch - Small / Front Bumper, Grille, Lamps - Scratch & Dent - Medium / (R) Front Fender, Molding - Scratch - Small / Roof - Scratch & Dent - Small / (L) Front Fender, Molding - Scratch - Small</p>
