General Information

Make	Toyota	Model	Vios
YOM	2025	Odo Meter Reading	2,729
Registration No.	CCG9246	Chassis No.	PA1B18F31S4287659
CC	1.3	Transmission	CVT
Fuel Type	Gas	Type of Body	Sedan
Colour	Black

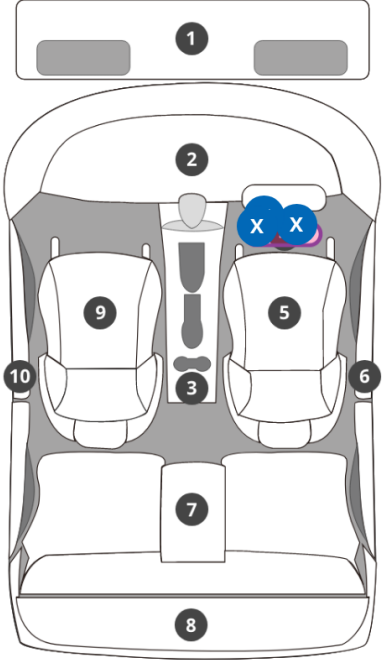
<p>a : Cut, Fray d : Loose, Deformed k : Animal Hair s : Smell t : Cigarette Burns x : Defective y : Stain</p>

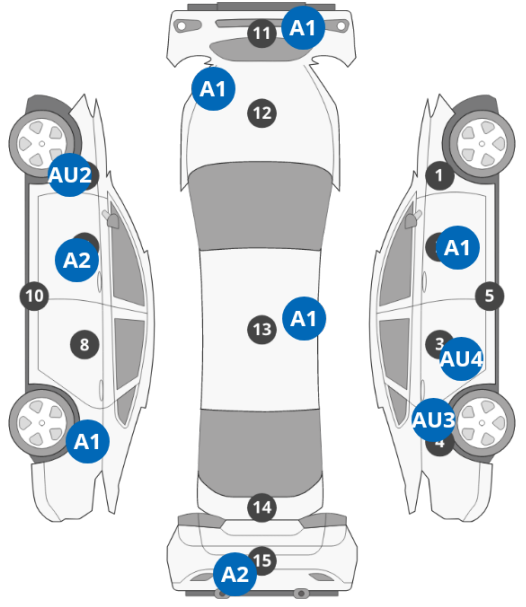
<p>A : Scratch AU : Scratch & Dent B : Modified C : Corrosion G : Stone chip P : Faded S : Rust SC : Rust & Corrosion U : Dent X : Defective Y : Crack, Gap</p>
<p>Remarks (R) Front Floor Mat - Missing - Yes / (L) Front Floor Mat - Missing - Yes / Mat Other - Missing - Yes</p>	<p>Remarks (R) Front Door, Molding - Scratch - Minimal / (R) Rear Door, Molding - Scratch & Dent - Large / (R) Rear Fender, Molding - Scratch & Dent - Medium / Rear Bumper, Lamps, Panels - Scratch - Small / (L) Rear Fender, Molding - Scratch - Minimal / (L) Front Door, Molding - Scratch - Small / (L) Front Fender, Molding - Scratch & Dent - Small / Bonnet, Headlight - Scratch - Minimal / Front Bumper, Grille, Lamps - Scratch - Minimal / Roof - Scratch - Minimal</p>
