General Information

Make	Toyota	Model	Vios
YOM	2024	Odo Meter Reading	27,606
Registration No.	NFR3787	Chassis No.	PA1B18F34R4249644
CC	1.3	Transmission	CVT
Fuel Type	Gas	Type of Body	Sedan
Colour	Red

Body / Panel Condition

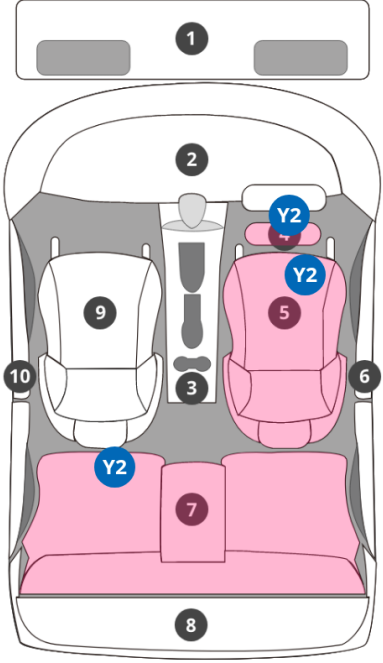
<p>a : Cut, Fray d : Loose, Deformed k : Animal Hair s : Smell t : Cigarette Burns x : Defective y : Stain</p>

<p>A : Scratch AU : Scratch & Dent B : Modified C : Corrosion G : Stone chip P : Faded S : Rust SC : Rust & Corrosion U : Dent X : Defective Y : Crack, Gap</p>
<p>Remarks (L) Front Floor Mat - Grime - Small / (R) Front Seat - Grime - Small / Rear Seat - Grime - Small</p>	<p>Remarks (R) Front Fender, Molding - Scratch & Dent - Minimal / (R) Front Door, Molding - Scratch - Small / (R) Rear Door, Molding - Scratch - Small / (R) Rear Fender, Molding - Scratch - Minimal / Rear Bumper, Lamps, Panels - Scratch & Dent - Large / Trunk Hood, Rear Gate - Scratch - Small / (L) Rear Fender, Molding - Scratch - Minimal / (L) Rear Door, Molding - Scratch - Minimal / (L) Front Door, Molding - Scratch - Minimal / (L) Mirror - Scratch - Small / (L) Front Fender, Molding - Scratch - Minimal / Bonnet, Headlight - Scratch - Minimal / Front Bumper, Grille, Lamps - Scratch & Dent - Small / Roof - Scratch - Minimal</p>

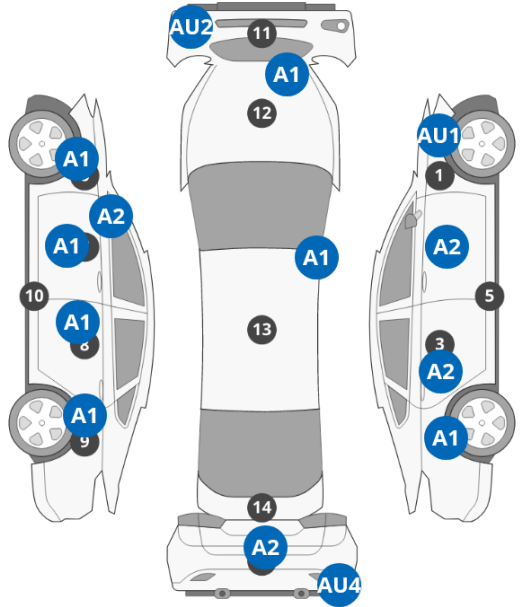
<p>Inspector Notes</p>
<p>With Lto plate, with warranty booklet, with jack and tools, 3keys, no spare tire, scratches on headlight, Cracked taillight</p>
