General Information

Make	Toyota	Model	Vios
YOM	2025	Odo Meter Reading	6,319
Registration No.	CCF9416	Chassis No.	PA1B18F36P4274537
CC	1.3	Transmission	CVT
Fuel Type	Gas	Type of Body	Sedan
Colour	Blue

Body / Panel Condition

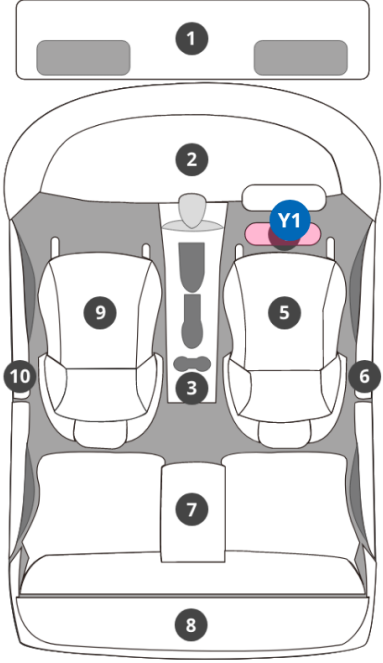
<p>a : Cut, Fray d : Loose, Deformed k : Animal Hair s : Smell t : Cigarette Burns x : Defective y : Stain</p>

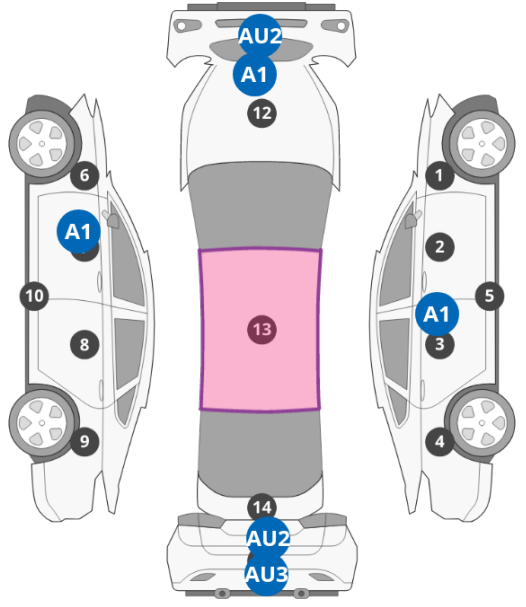
<p>A : Scratch AU : Scratch & Dent B : Modified C : Corrosion G : Stone chip P : Faded S : Rust SC : Rust & Corrosion U : Dent X : Defective Y : Crack, Gap</p>
Remarks (L) Front Floor Mat - Grime - Minimal	Remarks (R) Front Door - Repair Traces - Yes / Bonnet - Repair Traces - Yes / (R) Rear Door, Molding - Scratch - Minimal / Rear Bumper, Lamps, Panels - Scratch & Dent - Medium / Trunk Hood, Rear Gate - Scratch & Dent - Small / Roof - Repair mark - Yes / (L) Front Door, Molding - Scratch - Minimal / Bonnet, Headlight - Scratch - Minimal / Front Bumper, Grille, Lamps - Scratch & Dent - Small
Frame Evaluation : A	Functional Evaluation : A
Remarks Defects not found	Remarks Defects not found
