General Information

Make	Toyota	Model	Vios
YOM	2025	Odo Meter Reading	17,007
Registration No.	CCG3954	Chassis No.	PA1B18F33R4264829
CC	1.3	Transmission	CVT
Fuel Type	Gas	Type of Body	Sedan
Colour	Red

Body / Panel Condition

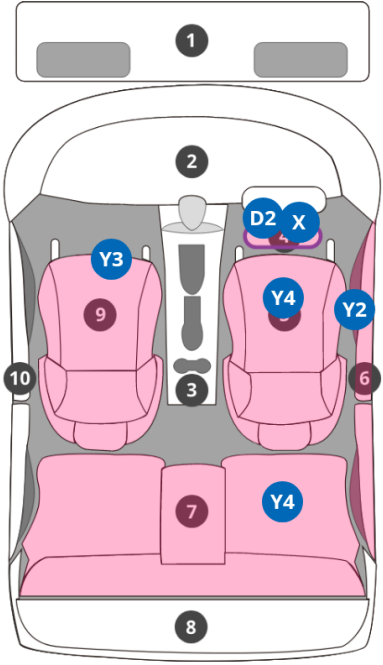
Interior Evaluation : C	Exterior Evaluation : E

<p>a : Cut, Fray d : Loose, Deformed k : Animal Hair s : Smell t : Cigarette Burns x : Defective y : Stain</p>

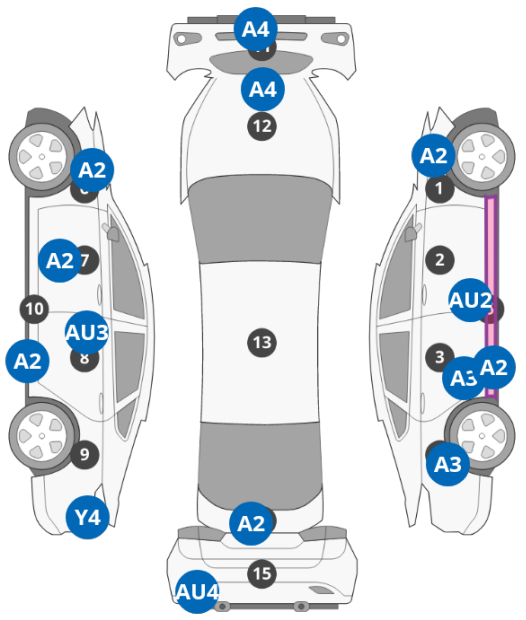
<p>A : Scratch AU : Scratch & Dent B : Modified C : Corrosion G : Stone chip P : Faded S : Rust SC : Rust & Corrosion U : Dent X : Defective Y : Crack, Gap</p>
<p>Remarks (R) Front Seat - Grime - Large / (R) Front Floor Mat - Missing - Yes / (R) Front Trim - Grime - Small / Rear Seat - Grime - Large / (L) Front Floor Mat - Worked - Small / (L) Front Seat - Grime - Medium</p>	<p>Remarks Front Bumper, Grille, Lamps - Scratch - Large / (R) Front Door, Molding - Scratch & Dent - Small / (R) Rear Fender, Molding - Scratch - Medium / (R) Rear Door, Molding - Scratch - Medium / Rear Bumper, Lamps, Panels - Scratch & Dent - Large / (L) Rear Fender, Molding - Crack, Gap - Large / (L) Rear Door, Molding - Scratch & Dent - Medium / (L) Front Fender, Molding - Scratch - Small / Bonnet, Headlight - Scratch - Large / (L) Front Door, Molding - Scratch - Small / (R) Front Fender, Molding - Scratch - Small / (L) Step, In-panel, Side Spoiler - Scratch - Small / (R) Step, In-panel, Side Spoiler - Scratch - Small / (R) Step, In-panel, Side Spoiler - Repair mark - Yes / Trunk Hood, Rear Gate - Scratch - Small</p>
