General Information

Make	Toyota	Model	Innova
YOM	2024	Odo Meter Reading	13,114
Registration No.	CCA8264	Chassis No.	PA2JAE8MXR0142543
CC	2.8	Transmission	A/T
Fuel Type	Diesel	Type of Body	Wagon
Colour	Red Mica Metallic

Body / Panel Condition

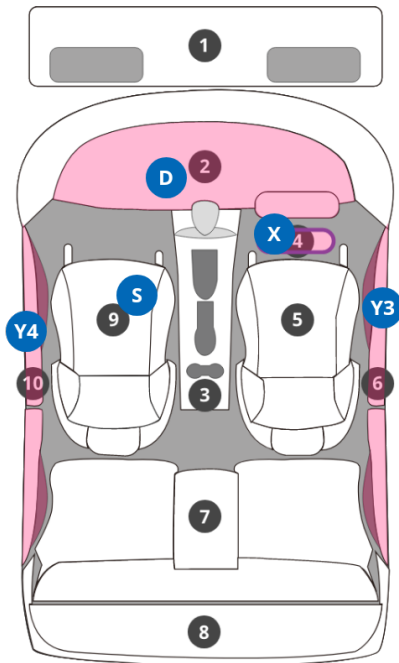
Interior Evaluation : C	Exterior Evaluation : E

<p>a : Cut, Fray d : Loose, Deformed k : Animal Hair s : Smell t : Cigarette Burns x : Defective y : Stain</p>

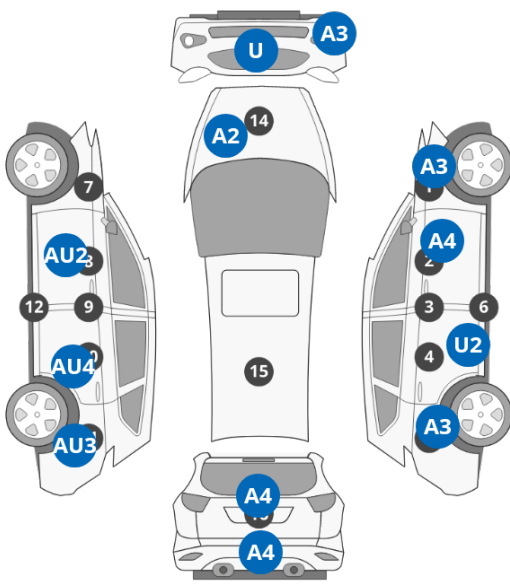
<p>A : Scratch AU : Scratch & Dent B : Modified C : Corrosion G : Stone chip P : Faded S : Rust SC : Rust & Corrosion U : Dent X : Defective Y : Crack, Gap</p>
<p>Remarks Dashboard - Traces of Adhesive Tape - Yes / Overall Interior - Smell - Yes / (L) Front Trim - Grime - Large / (R) Front Trim - Grime - Medium / (L) Front Floor Mat - Missing - Yes</p>	<p>Remarks (R) Front Fender, Molding - Scratch - Medium / Member (Bolted) - Dent - Yes / (R) Front Door, Molding - Scratch - Large / (R) Rear Door, Molding - Dent - Small / (R) Rear Fender, Molding - Scratch - Medium / Trunk Hood, Rear Gate - Scratch - Large / Rear Bumper, Lamps, Panels - Scratch - Large / (L) Rear Fender, Molding - Scratch & Dent - Medium / (L) Front Door, Molding - Scratch & Dent - Small / Front Bumper, Grille, Lamps - Scratch - Medium / Bonnet, Headlight - Scratch - Small / (L) Rear Door, Molding - Scratch & Dent - Large</p>
