General Information

Make	Toyota	Model	Vios
YOM	2021	Odo Meter Reading	101,350
Registration No.	CBM2548	Chassis No.	PA1B18F31M4140051
CC	1.3	Transmission	CVT
Fuel Type	Gas	Type of Body	Sedan
Colour	Silver

Body / Panel Condition

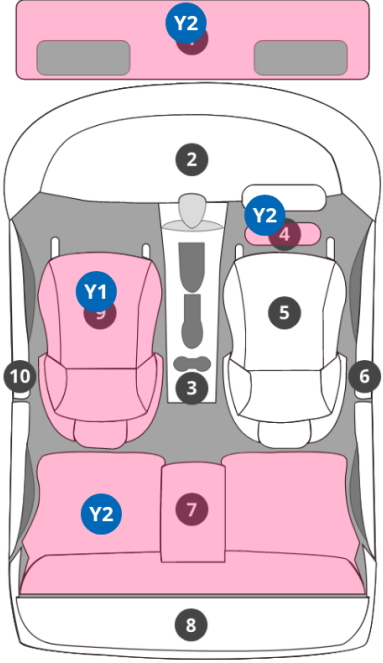
<p>a : Cut, Fray d : Loose, Deformed k : Animal Hair s : Smell t : Cigarette Burns x : Defective y : Stain</p>

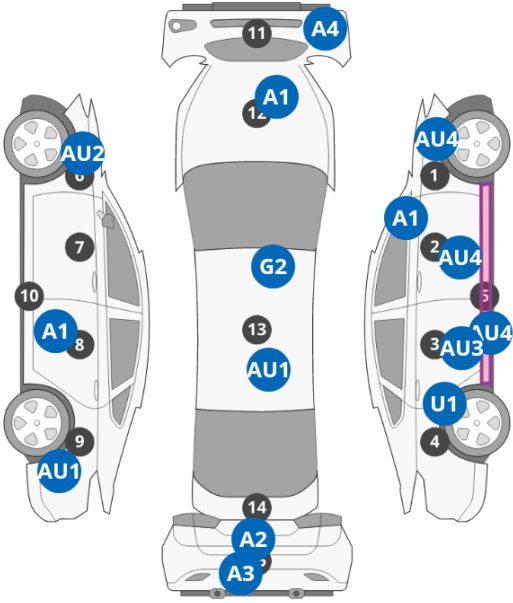
<p>A : Scratch AU : Scratch & Dent B : Modified C : Corrosion G : Stone chip P : Faded S : Rust SC : Rust & Corrosion U : Dent X : Defective Y : Crack, Gap</p>
<p>Remarks Ceiling - Grime - Small / Rear Seat - Grime - Small / (L) Front Floor Mat - Grime - Small / (L) Front Seat - Grime - Minimal</p>	<p>Remarks (R) Front Door - Repair Traces - Yes / (R) Step - Repair Traces - Yes / (R) Front Fender - Repair Traces - Yes / Bonnet - Repair Traces - Yes / (L) Front Door - Repair Traces - Yes / (L) Rear Door - Repair Traces - Yes / (L) Rear Fender - Repair Traces - Yes / Trunk Hood, Rear Gate - Repair Traces - Yes / (R) Rear Fender - Repair Traces - Yes / (R) Rear Door - Repair Traces - Yes / Roof - Repair Traces - Yes / (R) Front Fender, Molding - Scratch & Dent - Large / (R) Mirror - Scratch - Minimal / (R) Front Door, Molding - Scratch & Dent - Large / (R) Step, In-panel, Side Spoiler - Scratch & Dent - Large / (R) Rear Door, Molding - Scratch & Dent - Medium / (R) Step, In-panel, Side Spoiler - Repair mark - Yes / (R) Rear Fender, Molding - Dent - Minimal / Rear Bumper, Lamps, Panels - Scratch - Medium / Trunk Hood, Rear Gate - Scratch - Small / (L) Rear Fender, Molding - Scratch & Dent - Minimal / (L) Rear Door, Molding - Scratch - Minimal / (L) Front Fender, Molding - Scratch & Dent - Small / Front Bumper, Grille, Lamps - Scratch - Large / Bonnet, Headlight - Scratch - Minimal / Front Windshield - Scratch, Stone chip - Small / Roof - Scratch & Dent - Minimal</p>

<p>Inspector Notes</p>
<p>With Lto plate, 1key, no warranty booklet, no spare tire, no jack and tools, scratches on headlights, Crack taillight, battery weak, issue on radio, no bonet stand</p>
