General Information

Make	Toyota	Model	Veloz
YOM	2024	Odo Meter Reading	36,383
Registration No.	CCC4868	Chassis No.	MHFAB1BY5P3077354
CC	1.5	Transmission	CVT
Fuel Type	Gas	Type of Body	Wagon
Colour	Red

Body / Panel Condition

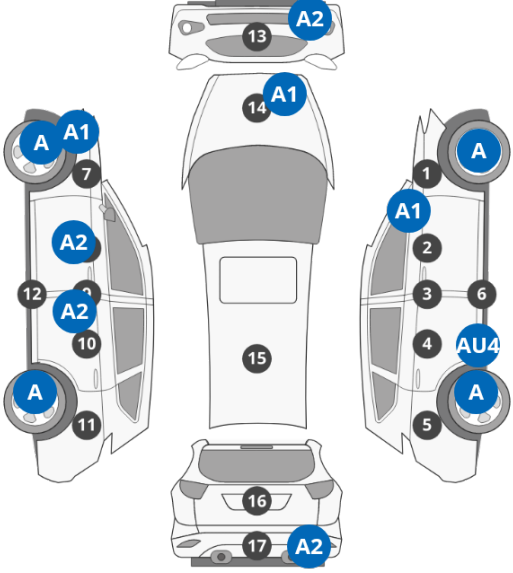
<p>A : Scratch AU : Scratch & Dent B : Modified C : Corrosion G : Stone chip P : Faded S : Rust SC : Rust & Corrosion U : Dent X : Defective Y : Crack, Gap</p>
<p>Remarks (R) Front Seat - Grime - Small / (L) Front Floor Mat - Grime - Small</p>	<p>Remarks (R) Step - Repair Traces - Yes / (R) Mirror - Scratch - Minimal / (R) Step, In-panel, Side Spoiler - Scratch & Dent - Large / (R) Front Tyre - Crack, Cut - Yes / (R) Rear Tyre - Crack, Cut - Yes / Rear Bumper, Lamps, Panels - Scratch - Small / (L) Rear Door, Molding - Scratch - Small / (L) Front Door, Molding - Scratch - Small / (L) Front Fender, Molding - Scratch - Minimal / (L) Rear Tyre - Crack, Cut - Yes / (L) Front Tyre - Crack, Cut - Yes / Front Bumper, Grille, Lamps - Scratch - Small / Bonnet, Headlight - Scratch - Minimal</p>

<p>Inspector Notes</p>
<p>With Lto plate, with warranty booklet, with spare tire, 2keys, no jack and tools, scratches on headlight and taillight</p>
