General Information

Make	Toyota	Model	Vios
YOM	2025	Odo Meter Reading	17,327
Registration No.	CCG3712	Chassis No.	PA1B18F39R4264849
CC	1.3	Transmission	CVT
Fuel Type	Gas	Type of Body	Sedan
Colour	Blue

Body / Panel Condition

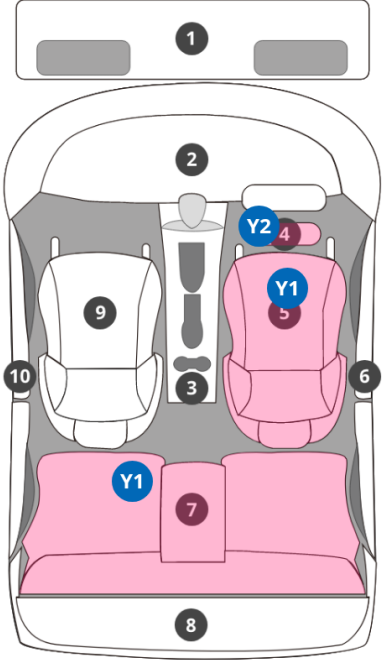
Interior Evaluation : A	Exterior Evaluation : C

<p>a : Cut, Fray d : Loose, Deformed k : Animal Hair s : Smell t : Cigarette Burns x : Defective y : Stain</p>

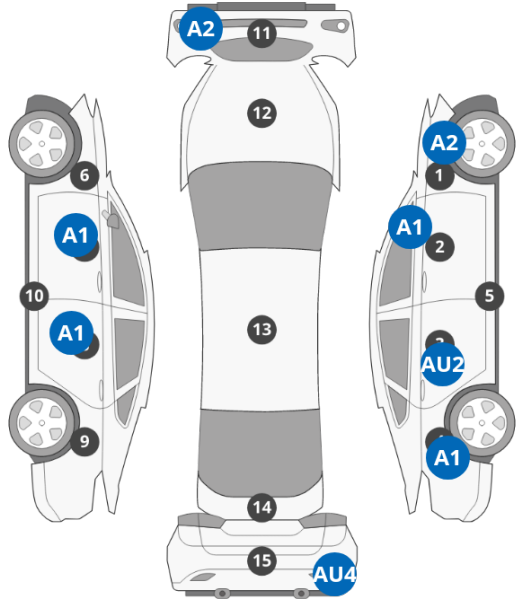
<p>A : Scratch AU : Scratch & Dent B : Modified C : Corrosion G : Stone chip P : Faded S : Rust SC : Rust & Corrosion U : Dent X : Defective Y : Crack, Gap</p>
<p>Remarks (R) Front Seat - Grime - Minimal / Rear Seat - Grime - Minimal / Mat Other - Grime - Small</p>	<p>Remarks (R) Front Fender, Molding - Scratch - Small / (R) Mirror - Scratch - Minimal / (R) Rear Door, Molding - Scratch & Dent - Small / (R) Rear Fender, Molding - Scratch - Minimal / Rear Bumper, Lamps, Panels - Scratch & Dent - Large / (L) Rear Door, Molding - Scratch - Minimal / (L) Front Door, Molding - Scratch - Minimal / Front Bumper, Grille, Lamps - Scratch - Small</p>
Frame Evaluation : A	Functional Evaluation : C
<p>Remarks Defects not found</p>	<p>Remarks Warning Lamps - Issue - Yes / Battery - Weak - Yes</p>

<p>Inspector Notes</p>
<p>With Lto plate, with warranty booklet, with spare tire and jack, 3keys, no tools, fender light issue,battery weak</p>
