General Information

Make	Toyota	Model	Vios
YOM	2024	Odo Meter Reading	24,362
Registration No.	NFF4565	Chassis No.	PA1B18F37R4234102
CC	1.3	Transmission	CVT
Fuel Type	Gas	Type of Body	Sedan
Colour	Blue

Body / Panel Condition

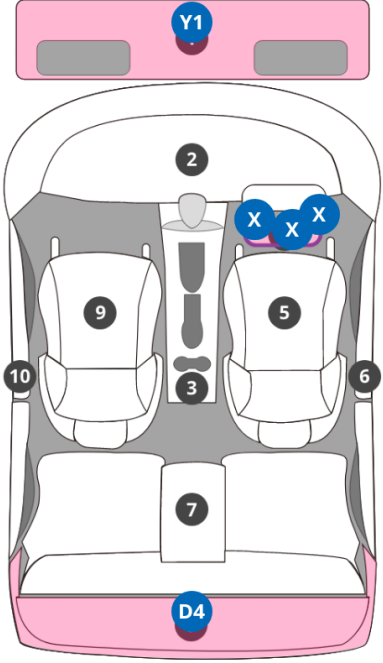
Interior Evaluation : C	Exterior Evaluation : D

<p>a : Cut, Fray d : Loose, Deformed k : Animal Hair s : Smell t : Cigarette Burns x : Defective y : Stain</p>

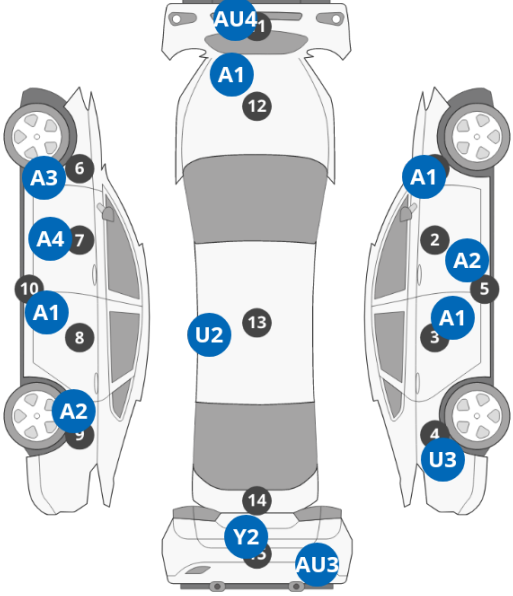
<p>A : Scratch AU : Scratch & Dent B : Modified C : Corrosion G : Stone chip P : Faded S : Rust SC : Rust & Corrosion U : Dent X : Defective Y : Crack, Gap</p>
<p>Remarks Ceiling - Grime - Minimal / (R) Front Floor Mat - Missing - Yes / (L) Front Floor Mat - Missing - Yes / Mat Other - Missing - Yes / Trunk Room - Loose, Deformed - Large</p>	<p>Remarks (R) Front Fender, Molding - Scratch - Minimal / (R) Front Door, Molding - Scratch - Small / (R) Rear Door, Molding - Scratch - Minimal / (R) Rear Fender, Molding - Dent - Medium / Rear Bumper, Lamps, Panels - Scratch & Dent - Medium / Trunk Hood, Rear Gate - Crack, Gap - Small / (L) Rear Fender, Molding - Scratch - Small / (L) Rear Door, Molding - Scratch - Minimal / (L) Front Door, Molding - Scratch - Large / (L) Front Fender, Molding - Scratch - Medium / Front Bumper, Grille, Lamps - Scratch & Dent - Large / Bonnet, Headlight - Scratch - Minimal / Roof - Dent - Small</p>

<p>Inspector Notes</p>
<p>With Lto plate, with spare tire, 1key, no warranty booklet, no jack and tools, scratches on headlights and taillights, trunk cover missing</p>
