General Information

Make	Toyota	Model	Vios
YOM	2022	Odo Meter Reading	37,777
Registration No.	NFL6736	Chassis No.	PA1B18F32N4178616
CC	1.3	Transmission	CVT
Fuel Type	Gas	Type of Body	Sedan
Colour	Red

Body / Panel Condition

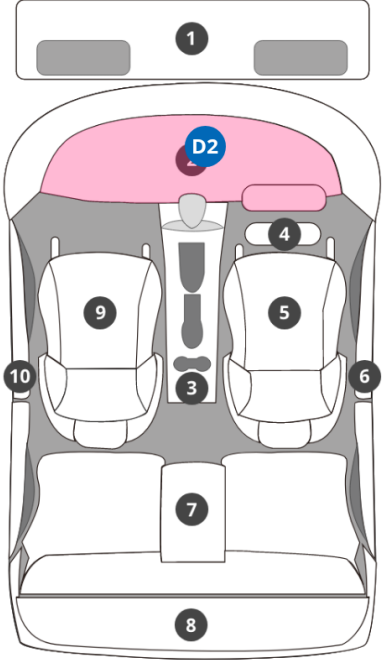
<p>a : Cut, Fray d : Loose, Deformed k : Animal Hair s : Smell t : Cigarette Burns x : Defective y : Stain</p>

<p>A : Scratch AU : Scratch & Dent B : Modified C : Corrosion G : Stone chip P : Faded S : Rust SC : Rust & Corrosion U : Dent X : Defective Y : Crack, Gap</p>
<p>Remarks Glove Box - Loose, Deformed - Small</p>	<p>Remarks (R) Front Fender, Molding - Scratch - Minimal / (R) Front Door, Molding - Scratch - Minimal / (R) Rear Door, Molding - Scratch & Dent - Small / (R) Rear Fender, Molding - Scratch - Minimal / Trunk Hood, Rear Gate - Scratch - Minimal / Rear Bumper, Lamps, Panels - Crack, Gap - Medium / (L) Rear Fender, Molding - Scratch & Dent - Minimal / (L) Rear Door, Molding - Scratch - Minimal / (L) Front Door, Molding - Scratch - Minimal / (L) Front Fender, Molding - Scratch & Dent - Medium / Front Bumper, Grille, Lamps - Scratch - Minimal / Bonnet, Headlight - Scratch - Minimal / Roof - Scratch - Minimal</p>

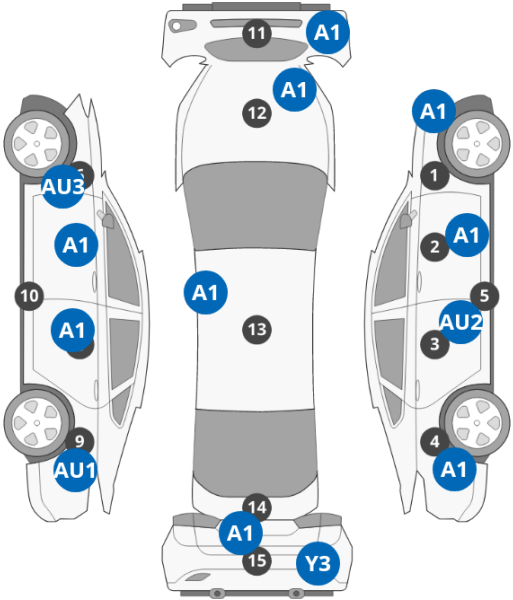
<p>Inspector Notes</p>
<p>With spare tire, 1key, No Lto plate, no warranty booklet, no jack and tools, scratches on headlight, Crack taillight</p>
