General Information

Make	Toyota	Model	Hiace
YOM	2025	Odo Meter Reading	28,844
Registration No.	DBS7434	Chassis No.	JTFJ02P1R5039161
CC	3.0	Transmission	M/T
Fuel Type	Diesel	Type of Body	Van
Colour	White

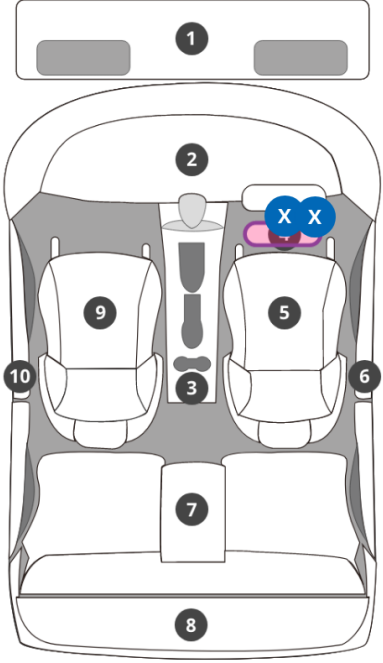
Interior Evaluation : B	Exterior Evaluation : E

<p>a : Cut, Fray d : Loose, Deformed k : Animal Hair s : Smell t : Cigarette Burns x : Defective y : Stain</p>

<p>A : Scratch AU : Scratch & Dent B : Modified C : Corrosion G : Stone chip P : Faded S : Rust SC : Rust & Corrosion U : Dent X : Defective Y : Crack, Gap</p>
<p>Remarks (R) Front Floor Mat - Missing - Yes / (L) Front Floor Mat - Missing - Yes</p>	<p>Remarks (R) Front Fender, Molding - Scratch - Minimal / (R) Mirror - Scratch - Small / (R) Center Panel - Scratch - Minimal / (R) Step, In-panel, Side Spoiler - Scratch - Medium / (R) Rear Fender, Molding - Scratch - Small / Rear Windshield - Damaged - Large / Trunk Hood, Rear Gate - Modified - Large / Muffler and Undercarriage Parts - Dent, Bent - Yes / Rear Bumper, Lamps, Panels - Scratch - Medium / (L) Rear Fender, Molding - Scratch - Minimal / Roof - Scratch & Dent - Large / (L) Front Door, Molding - Scratch - Minimal / (L) Mirror - Scratch - Small / Front Bumper, Grille, Lamps - Scratch - Medium / Bonnet, Headlight - Scratch - Minimal</p>

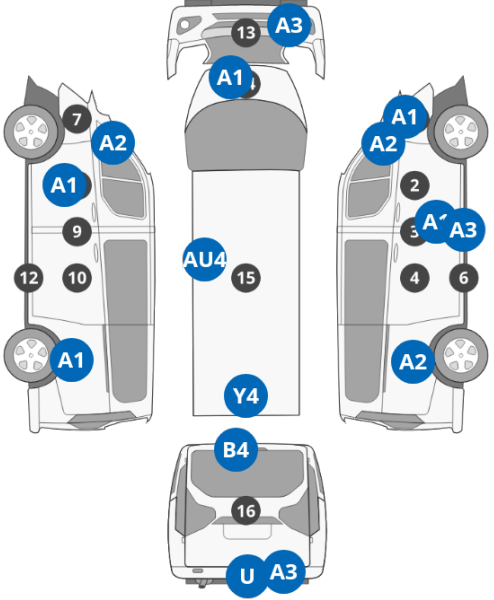
<p>Inspector Notes</p>
<p>With Lto plate, with warranty booklet, with spare tire and 3, 1key, no tools,scratches on headlight and taillight, no rear windshield,</p>
