General Information

Make	Toyota	Model	Innova
YOM	2025	Odo Meter Reading	31,445
Registration No.	NEY7078	Chassis No.	PA2JA82MR0145455
CC	2.8	Transmission	A/T
Fuel Type	Diesel	Type of Body	Wagon
Colour	Blackish Red Mica

Body / Panel Condition

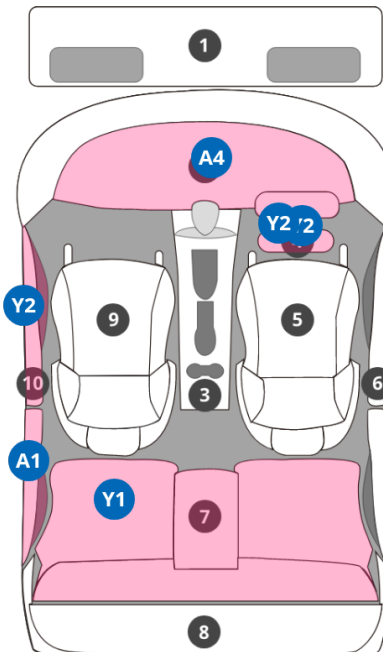
Interior Evaluation : C	Exterior Evaluation : A

<p>a : Cut, Fray d : Loose, Deformed k : Animal Hair s : Smell t : Cigarette Burns x : Defective y : Stain</p>

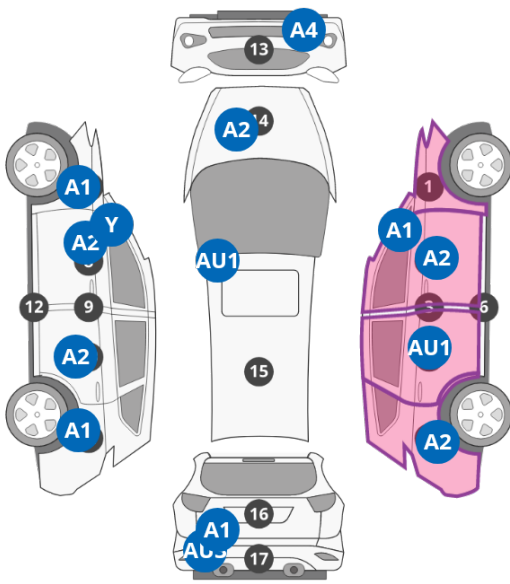
<p>A : Scratch AU : Scratch & Dent B : Modified C : Corrosion G : Stone chip P : Faded S : Rust SC : Rust & Corrosion U : Dent X : Defective Y : Crack, Gap</p>
<p>Remarks Steering Wheel - Worn, Peel, Crack - Large / (L) Front Trim - Grime - Small / (L) Front Floor Mat - Grime - Small / (L) Rear Trim - Cut, Crack - Minimal / Mat Other - Grime - Small / Rear Seat - Grime - Minimal</p>	<p>Remarks Defects not found</p>
Frame Evaluation : A	Functional Evaluation : A
<p>Remarks Defects not found</p>	<p>Remarks Reverse Camera - N/A - Yes / Horn - Issue - Yes / Spare Key - Issue - Unexist</p>

<p>Inspector Notes</p>
<p>1key, No Lto plate,no warranty booklet, no spare tire, no jack and tools,scratches on headlights and taillights</p>
