General Information

Make	Toyota	Model	Vios
YOM	2025	Odo Meter Reading	3,771
Registration No.	CDA2659	Chassis No.	PA1B18F33S4291907
CC	1.3	Transmission	CVT
Fuel Type	Gas	Type of Body	Sedan
Colour	Blackish Red Mica

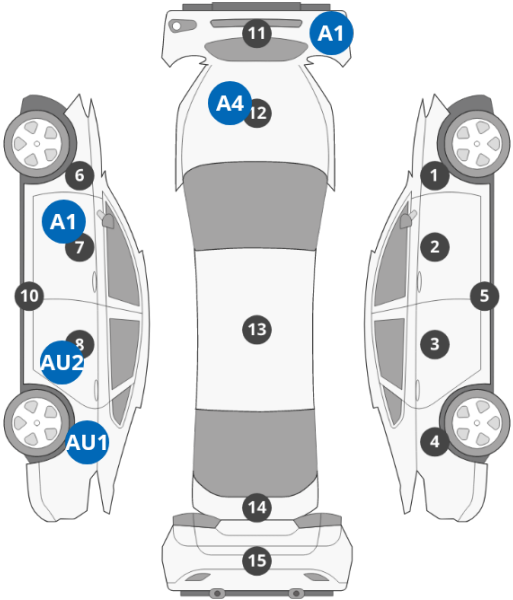
<p>A : Scratch AU : Scratch & Dent B : Modified C : Corrosion G : Stone chip P : Faded S : Rust SC : Rust & Corrosion U : Dent X : Defective Y : Crack, Gap</p>
Remarks Defects not found	Remarks (L) Rear Fender, Molding - Scratch & Dent - Minimal / (L) Front Door, Molding - Scratch - Minimal / Bonnet, Headlight - Scratch - Large / Front Bumper, Grille, Lamps - Scratch - Minimal / (L) Rear Door, Molding - Scratch & Dent - Small
Frame Evaluation : A	Functional Evaluation : B
Remarks Defects not found	Remarks Retractable Mirror - Issue - Yes / Battery - Weak - Yes / Audio, Radio - Issue - Yes / Reverse Camera - N/A - Yes / Spare Key - Issue - Unexist

Inspector Notes
With Lto plate, with tools, 1key, no warranty booklet, no spare tire and jack, issue on radio,
