General Information

Make	Toyota	Model	Wigo
YOM	2021	Odo Meter Reading	58,060
Registration No.	GAV3998	Chassis No.	MHKA4DF5FMJ058226
CC	1.0	Transmission	A/T
Fuel Type	Gas	Type of Body	Hatchback
Colour	Gray

Body / Panel Condition

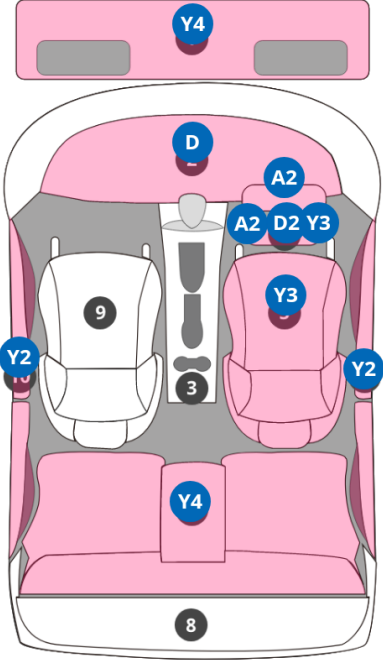
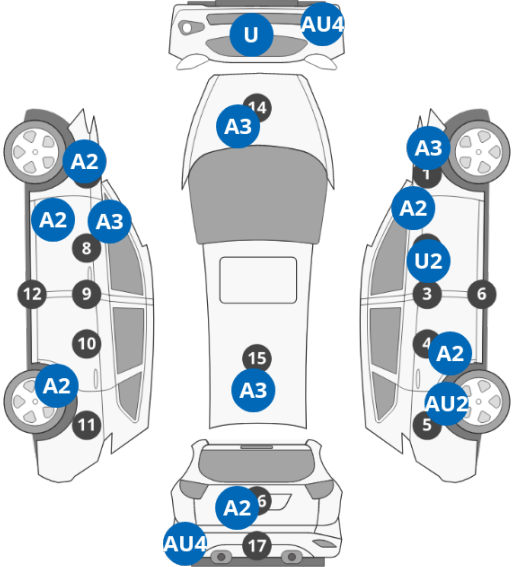
Interior Evaluation : D	Exterior Evaluation : E

<p>a : Cut, Fray d : Loose, Deformed k : Animal Hair s : Smell t : Cigarette Burns x : Defective y : Stain</p>	<p>A : Scratch AU : Scratch & Dent B : Modified C : Corrosion G : Stone chip P : Faded S : Rust SC : Rust & Corrosion U : Dent X : Defective Y : Crack, Gap</p>
<p>Remarks (R) Front Seat - Grime - Medium / (R) Front Floor Mat - Grime - Medium / (R) Front Trim - Grime - Small / Dashboard - Traces of Adhesive Tape - Yes / Ceiling - Grime - Large / Rear Seat - Grime - Large / Mat Other - Worked - Small / (L) Front Trim - Grime - Small / (L) Front Floor Mat - Cut, Crack - Small / Steering Wheel - Worn, Peel, Crack - Small</p>	<p>Remarks (R) Front Fender, Molding - Scratch - Medium / (R) Mirror - Scratch - Small / (R) Front Door, Molding - Dent - Small / (R) Rear Door, Molding - Scratch - Small / (R) Rear Fender, Molding - Scratch & Dent - Small / Trunk Hood, Rear Gate - Scratch - Small / Rear Bumper, Lamps, Panels - Scratch & Dent - Large / (L) Rear Fender, Molding - Scratch - Small / (L) Front Door, Molding - Scratch - Small / (L) Mirror - Scratch - Medium / (L) Front Fender, Molding - Scratch - Small / Bonnet, Headlight - Scratch - Medium / Front Bumper, Grille, Lamps - Scratch & Dent - Large / Roof - Scratch - Medium / Member (Bolted) - Dent - Yes</p>

Frame Evaluation : C	Functional Evaluation : A
<p>Remarks Front Cross Member Support - Traces of Bending, or Marks of Panel Repair ? - Yes / Left Front Inside Panel (Front Side) - Traces of Bending, or Marks of Panel Repair ? - Yes</p>	<p>Remarks Spare Key - Issue - Unexist</p>

Inspector Notes
<p>Possible flooding. Crack right tail light. Trunk floor deformed. With warranty booklet, spare tire and jack. Without tools. Incomplete seat cover. 1 key. With LTO plate.</p>
