General Information

Make	Toyota	Model	Wigo
YOM	2024	Odo Meter Reading	13,304
Registration No.	DBO9449	Chassis No.	MHKAA1BC0RJ020986
CC	1.0	Transmission	CVT
Fuel Type	Gas	Type of Body	Hatchback
Colour	Gray

Body / Panel Condition

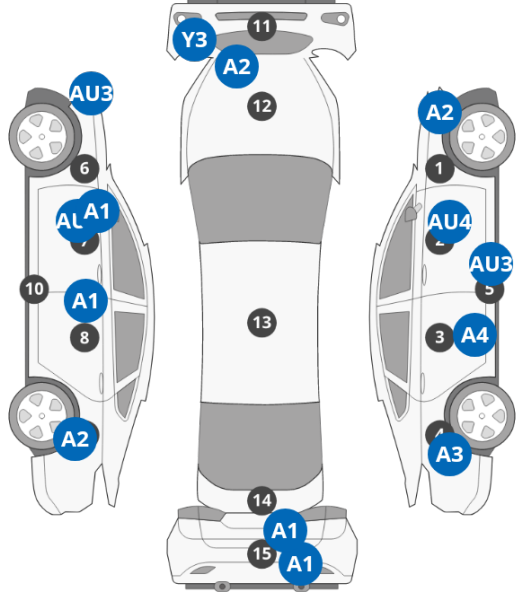
<p>A : Scratch AU : Scratch & Dent B : Modified C : Corrosion G : Stone chip P : Faded S : Rust SC : Rust & Corrosion U : Dent X : Defective Y : Crack, Gap</p>
Remarks Defects not found	Remarks (R) Front Fender, Molding - Scratch - Small / (R) Front Door, Molding - Scratch & Dent - Large / (R) Step, In-panel, Side Spoiler - Scratch & Dent - Medium / (R) Rear Door, Molding - Scratch - Large / (R) Rear Fender, Molding - Scratch - Medium / Rear Bumper, Lamps, Panels - Scratch - Minimal / Trunk Hood, Rear Gate - Scratch - Minimal / (L) Rear Fender, Molding - Scratch - Small / (L) Rear Door, Molding - Scratch - Minimal / (L) Front Door, Molding - Scratch & Dent - Medium / (L) Mirror - Scratch - Minimal / (L) Front Fender, Molding - Scratch & Dent - Medium / Front Bumper, Grille, Lamps - Crack, Gap - Medium / Bonnet, Headlight - Scratch - Small

Inspector Notes
With Lto plate, with warranty booklet, with spare tire and jack, 1key,no tools, scratches on headlight and taillight
