General Information

Make	Hino	Model	XZU309LN
YOM	2025	Odo Meter Reading	1,476
Registration No.	NKP2681	Chassis No.	MJEACN4F4S5003758
CC	4.0	Transmission	M/T
Fuel Type	Diesel	Type of Body	Utility Vehicle
Colour	White

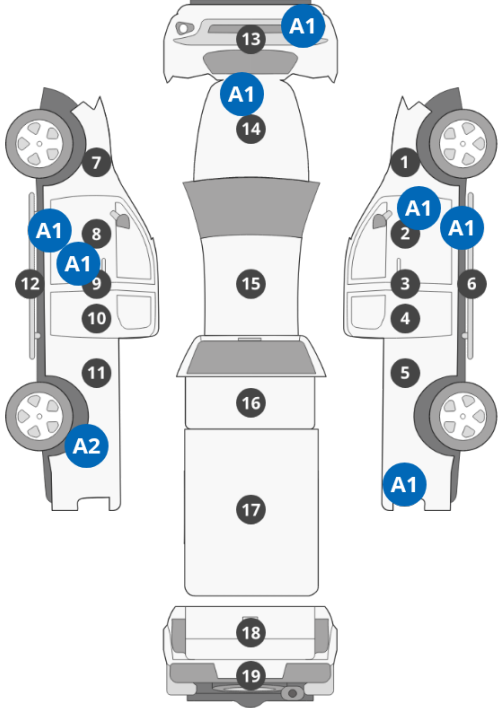
<p>A : Scratch AU : Scratch & Dent B : Modified C : Corrosion G : Stone chip P : Faded S : Rust SC : Rust & Corrosion U : Dent X : Defective Y : Crack, Gap</p>
Remarks Defects not found	Remarks (R) Front Door, Molding - Scratch - Minimal / (R) Step, In-panel, Side Spoiler - Scratch - Minimal / (R) Side Gate - Scratch - Minimal / (L) Side Gate - Scratch - Small / (L) Front Door, Molding - Scratch - Minimal / (L) Step, In-panel, Side Spoiler - Scratch - Minimal / Front Bumper, Grille, Lamps - Scratch - Minimal / Bonnet, Headlight - Scratch - Minimal
Frame Evaluation : A	Functional Evaluation : C
Remarks Defects not found	Remarks Air Conditioner - Function - Weak / Reverse Camera - N/A - Yes / Spare Key - Issue - Unexist

Inspector Notes
No Lto plate, with spare tire, with jack and tools, 1key, no warranty booklet, aircon issue
