General Information

Make	Toyota	Model	Vios
YOM	2025	Odo Meter Reading	17,556
Registration No.	HAH6399	Chassis No.	PENDING
CC	1.3	Transmission	CVT
Fuel Type	Gas	Type of Body	Sedan
Colour	Black

Body / Panel Condition

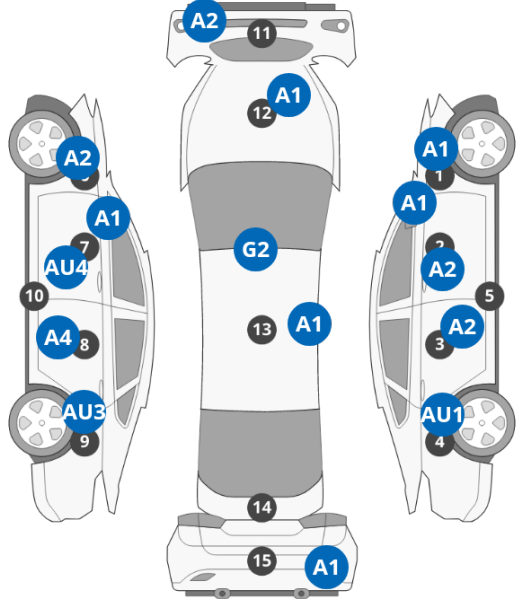
<p>A : Scratch AU : Scratch & Dent B : Modified C : Corrosion G : Stone chip P : Faded S : Rust SC : Rust & Corrosion U : Dent X : Defective Y : Crack, Gap</p>
Remarks Defects not found	Remarks (R) Front Fender, Molding - Scratch - Minimal / (R) Mirror - Scratch - Minimal / (R) Front Door, Molding - Scratch - Small / (R) Rear Door, Molding - Scratch - Small / (R) Rear Fender, Molding - Scratch & Dent - Minimal / Rear Bumper, Lamps, Panels - Scratch - Minimal / (L) Rear Fender, Molding - Scratch & Dent - Medium / (L) Rear Door, Molding - Scratch - Large / (L) Front Door, Molding - Scratch & Dent - Large / (L) Front Fender, Molding - Scratch - Small / (L) Mirror - Scratch - Minimal / Front Bumper, Grille, Lamps - Scratch - Small / Bonnet, Headlight - Scratch - Minimal / Front Windshield - Scratch, Stone chip - Small / Roof - Scratch - Minimal

Inspector Notes
With Lto plate, with warranty booklet, with spare tire, with jack and tools, 3keys, scratches on headlight and taillight
